Access Compliance Report

Public Rights-of-Way

(Curb Ramps)

Intersection ID: N/A	Main Street: PIMA_COTTON_DR	Cross Street: KANFER_CT	Location: NW
ADA ID: AE0DF338EFC5	Ramp Type: BlendTrans2	Initial Pass/Fail: Pass	Overall Compliance: No
		Severity Score: 10

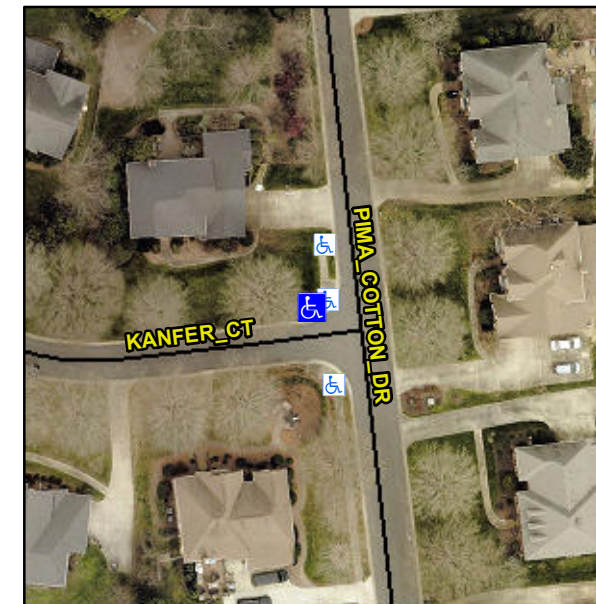
Compliance	Description	Data	Compliance	Description	Data
N/A	Ramp Length (in)	98.0	Yes	BlendTrans Slope (%)	3.1
Yes	Ramp Width (in)	48.0	Yes	BlendTrans XSlope (%)	1.2
N/A	Flare Type LT	None	N/A	Flare Type RT	None
N/A	Flare Slope LT (%)	N/A	N/A	Flare Slope RT (%)	N/A
N/A	Flare Traversable LT?	N/A	N/A	Flare Traversable RT?	N/A
N/A	Landing Length (in)	N/A	No	DWS Provided?	No
N/A	Landing Width (in)	N/A	N/A	DWS Contrast?	No
N/A	Landing Slope (%)	N/A	N/A	DWS Length (in)	N/A
N/A	Landing X Slope (%)	N/A	N/A	DWS Full Width?	No
N/A	Landing Curb? (Y/N)	No	N/A	DWS Offset (in)	N/A
N/A	Shared Landing?	No			
Yes	Gutter Ponding?	No	Yes	Gutter Slope (%)	3.9
Yes	Gutter Lip Ht (in)	0.0	No	Gutter X Slope (%)	2.1
N/A	Painted X Walk1?	No	N/A	Painted X Walk2?	N/A
	X Walk 1 Direction	To S		X Walk 2 Direction	N/A
	X Walk 1 Width (in)	N/A		X Walk 2 Width (in)	N/A
	X Walk 1 Slope (%)	2.5		X Walk 2 Slope (%)	N/A
	X Walk 1 X Slope (%)	3.1		X Walk 2 X Slope (%)	N/A

N/A	Ramp inside XWalk1?	N/A	N/A	Ramp inside XWalk2?	N/A
	Road Slope (%)	3.1		Clear Space?	Yes
	Road X Slope (%)	2.5	N/A	Clear Space to XWalk (in)	N/A
Yes	Any Obstructions?	No	Yes	Storm Grate/Utility Hazard?	No
	Obstruction Type			Storm Grate/Utility Type	
		N/A			N/A
			Yes	Surface Condition? (G/P)	Good
			No	Curb Slope (%)	8.3

Remove & Replace Curb Ramp With Two New Directional Ramps or Equivalent. Remove & Replace Gutter.

Not Found, R305, R304.5.3
