Access Compliance Report

Public Rights-of-Way

(Curb Ramps)

Intersection ID: 11467	Main Street: WALNUT_AV	Cross Street: LELA_AV	Location: SE
ADA ID: AE10662710C9	Ramp Type: Perp	Initial Pass/Fail: Fail	Overall Compliance: No
Codes/Mitigation Info/Possible Solution		Field Measurements/Component Compliance	
Severity Score: 8.75

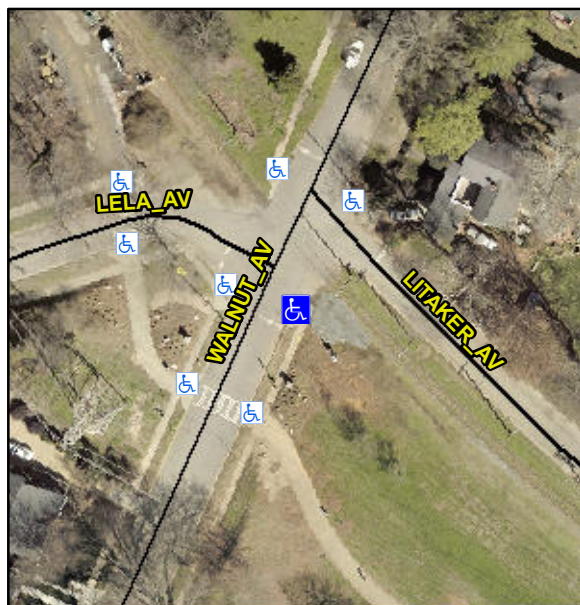
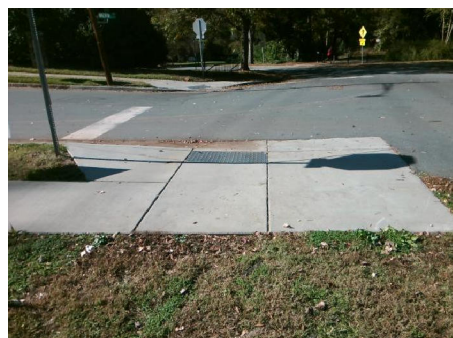
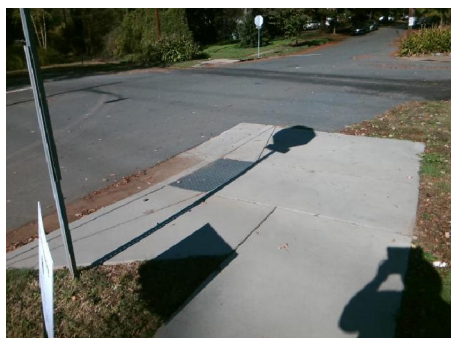
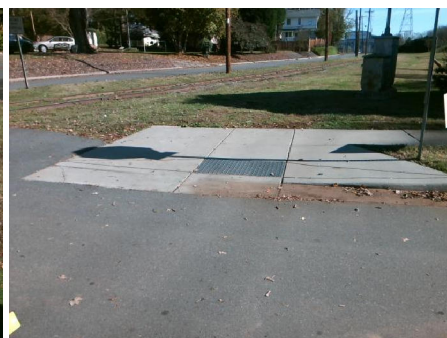
Not Found, R304.5.1

Compliance	Description	Data	Compliance	Description	Data
N/A	Ramp Length (in)	59.0	Yes	Ramp Slope (%)	7.0
No	Ramp Width (in)	47.5	Yes	Ramp XSlope (%)	1.1
N/A	Flare Type LT	N/A	N/A	Flare Type RT	N/A
N/A	Flare Slope LT (%)	N/A	N/A	Flare Slope RT (%)	N/A
N/A	Flare Traversable LT?	N/A	N/A	Flare Traversable RT?	N/A
N/A	Landing Length (in)	N/A	N/A	DWS Provided?	N/A
N/A	Landing Width (in)	N/A	N/A	DWS Contrast?	N/A
N/A	Landing Slope (%)	N/A	N/A	DWS Length (in)	N/A
N/A	Landing X Slope (%)	N/A	N/A	DWS Full Width?	N/A
N/A	Landing Curb? (Y/N)	N/A	N/A	DWS Offset (in)	N/A
N/A	Shared Landing?	N/A			
N/A	Gutter Ponding?	Yes	N/A	Gutter Slope (%)	N/A
N/A	Gutter Lip Ht (in)	0.5	N/A	Gutter X Slope (%)	N/A
N/A	Painted X Walk1?	No	N/A	Painted X Walk2?	N/A
	X Walk 1 Direction	To NW		X Walk 2 Direction	N/A
N/A	X Walk 1 Width (in)	N/A	N/A	X Walk 2 Width (in)	N/A
	X Walk 1 Slope (%)	3.2		X Walk 2 Slope (%)	N/A
	X Walk 1 X Slope (%)	1.0		X Walk 2 X Slope (%)	N/A

N/A	Ramp inside XWalk1?	N/A	N/A	Ramp inside XWalk2?	N/A
	Road Slope (%)	N/A	N/A	Clear Space?	N/A
	Road X Slope (%)	N/A	N/A	Clear Space to XWalk (in)	N/A
N/A	Any Obstructions?	N/A	N/A	Storm Grate/Utility Hazard?	N/A
	Obstruction Type			Storm Grate/Utility Type	
		N/A			N/A
		Yes		Surface Condition? (G/P)	Good

Remove & Replace Entire Ramp.

Total Cost: \$ 1850.00
