Intersection ID: 18174	Main Street: EAGLEWOOD_AV	Cross Street: MONROE_RD	Location:	NW
ADA ID: AE14EE217212	Ramp Type: PerpDiag	Initial Pass/Fail: Fail	Overall Compliance: No	Severity Score: 8.75

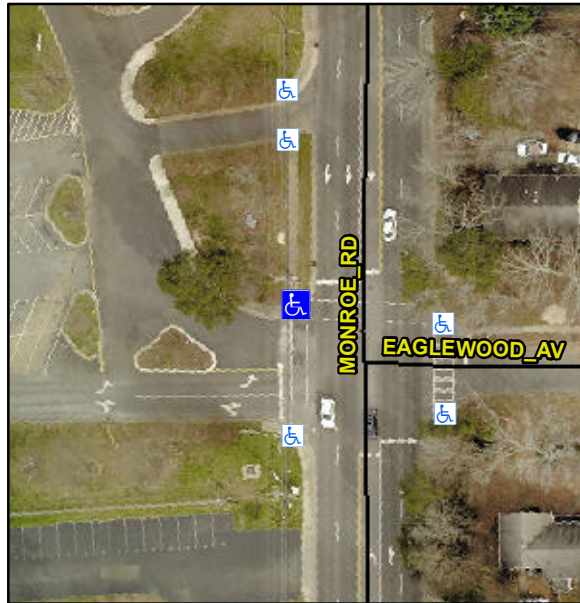
Compliance	Description	Data	Compliance	Description	Data
N/A	Ramp Length (in)	73.0	Yes	Ramp Slope (%)	5.2
No	Ramp Width (in)	41.0	Yes	Ramp XSlope (%)	0.8
N/A	Flare Type LT	N/A	N/A	Flare Type RT	N/A
N/A	Flare Slope LT (%)	N/A	N/A	Flare Slope RT (%)	N/A
N/A	Flare Traversable LT?	N/A	N/A	Flare Traversable RT?	N/A
N/A	Landing Length (in)	N/A	N/A	DWS Provided?	N/A
N/A	Landing Width (in)	N/A	N/A	DWS Contrast?	N/A
N/A	Landing Slope (%)	N/A	N/A	DWS Length (in)	N/A
N/A	Landing X Slope (%)	N/A	N/A	DWS Full Width?	N/A
N/A	Landing Curb? (Y/N)	N/A	N/A	DWS Offset (in)	N/A
N/A	Shared Landing?	N/A			
N/A	Gutter Ponding?	N/A	N/A	Gutter Slope (%)	N/A
N/A	Gutter Lip Ht (in)	N/A	N/A	Gutter X Slope (%)	N/A
N/A	Painted X Walk1?	Yes	N/A	Painted X Walk2?	Yes
	X Walk 1 Direction	To S		X Walk 2 Direction	To E
N/A	X Walk 1 Width (in)	86.0	N/A	X Walk 2 Width (in)	108.0
	X Walk 1 Slope (%)	0.7		X Walk 2 Slope (%)	1.8
	X Walk 1 X Slope (%)	0.9		X Walk 2 X Slope (%)	0.5

N/A	Ramp inside XWalk1?	Yes	N/A	Ramp inside XWalk2?	Yes
	Road Slope (%)	1.3	N/A	Clear Space?	N/A
	Road X Slope (%)	1.9	N/A	Clear Space to XWalk (in)	N/A
N/A	Any Obstructions?	N/A	N/A	Storm Grate/Utility Hazard?	N/A
	Obstruction Type			Storm Grate/Utility Type	
		N/A			N/A
			Yes	Surface Condition? (G/P)	Good

**Remove & Replace Curb Ramp With Two New Directional Ramps or Equivalent.**

Total Cost: \$ 3200.00
