# Access Compliance Report

## Public Rights-of-Way

### (Curb Ramps)

Intersection ID: 49130	Main Street: AUBURN_HILL_LN	Cross Street: WILTSHIRE_RIDGE_LN	Location: NW
ADA ID: AE196D99D86B	Ramp Type: Perp	Initial Pass/Fail: Fail	Overall Compliance: No
Severity Score: 8.75			
Codes/Mitigation Info/Possible Solution		Field Measurements/Component Compliance

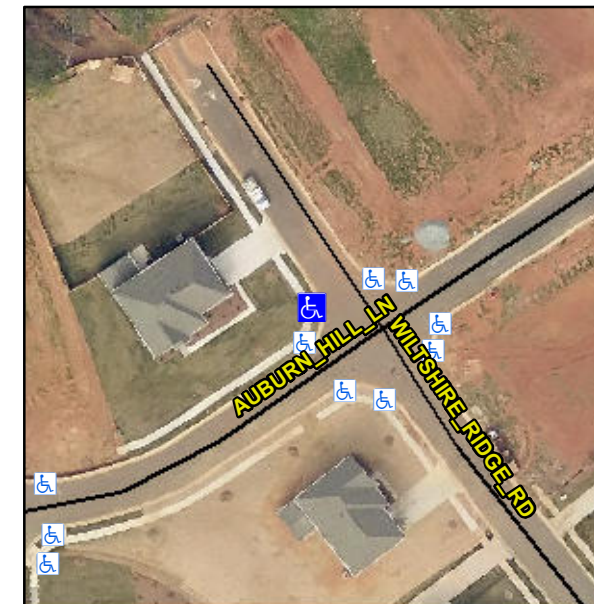
**Not Found, R304.5.1**

Compliance	Description	Data	Compliance	Description	Data
N/A	Ramp Length (in)	48.5	Yes	Ramp Slope (%)	5.0
No	Ramp Width (in)	45.0	Yes	Ramp XSlope (%)	0.5
N/A	Flare Type LT	N/A	N/A	Flare Type RT	N/A
N/A	Flare Slope LT (%)	N/A	N/A	Flare Slope RT (%)	N/A
N/A	Flare Traversable LT?	N/A	N/A	Flare Traversable RT?	N/A
N/A	Landing Length (in)	N/A	N/A	DWS Provided?	N/A
N/A	Landing Width (in)	N/A	N/A	DWS Contrast?	N/A
N/A	Landing Slope (%)	N/A	N/A	DWS Length (in)	N/A
N/A	Landing X Slope (%)	N/A	N/A	DWS Full Width?	N/A
N/A	Landing Curb? (Y/N)	N/A	N/A	DWS Offset (in)	N/A
N/A	Shared Landing?	N/A			
N/A	Gutter Ponding?	N/A	N/A	Gutter Slope (%)	N/A
N/A	Gutter Lip Ht (in)	N/A	N/A	Gutter X Slope (%)	N/A
N/A	Painted X Walk1?	No	N/A	Painted X Walk2?	N/A
	X Walk 1 Direction	To E		X Walk 2 Direction	N/A
N/A	X Walk 1 Width (in)	N/A	N/A	X Walk 2 Width (in)	N/A
	X Walk 1 Slope (%)	4.2		X Walk 2 Slope (%)	N/A
	X Walk 1 X Slope (%)	0.8		X Walk 2 X Slope (%)	N/A

N/A	Ramp inside XWalk1?	N/A	N/A	Ramp inside XWalk2?	N/A
	Road Slope (%)	N/A	N/A	Clear Space?	N/A
	Road X Slope (%)	N/A	N/A	Clear Space to XWalk (in)	N/A
N/A	Any Obstructions?	N/A	N/A	Storm Grate/Utility Hazard?	N/A
	Obstruction Type			Storm Grate/Utility Type	
		N/A			N/A
			Yes	Surface Condition? (G/P)	Good

**Remove & Replace Entire Ramp.**

Total Cost: \$ 1850.00
