Access Compliance Report

Public Rights-of-Way

(Curb Ramps)

Intersection ID: 30280	Main Street: CHALLENGER_DR	Cross Street: JUPITER_LN	Location:	E
ADA ID: AE1AC977864A	Ramp Type: BlendTrans1	Initial Pass/Fail: Fail	Overall Compliance: No	Severity Score: 12.5

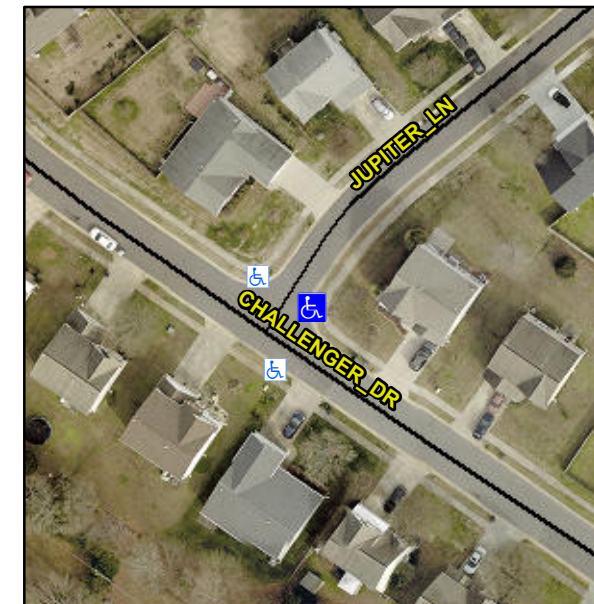
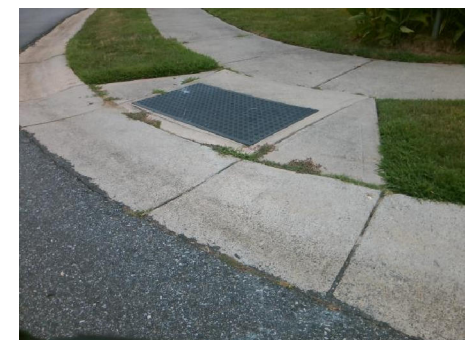
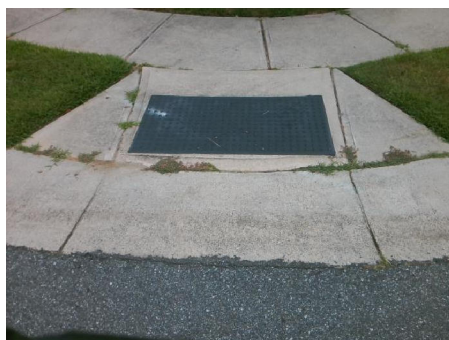
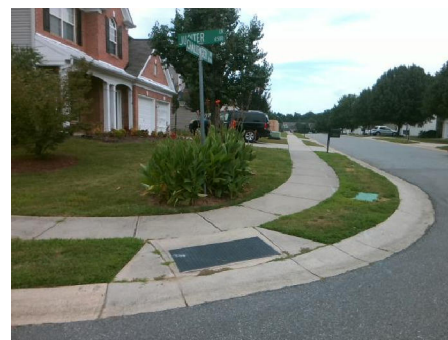
Not Found, R304.5.3

Compliance	Description	Data	Compliance	Description	Data
N/A	Ramp Length (in)	47.5	Yes	BlendTrans Slope (%)	3.6
Yes	Ramp Width (in)	53.0	No	BlendTrans XSlope (%)	5.2
N/A	Flare Type LT	N/A	N/A	Flare Type RT	N/A
N/A	Flare Slope LT (%)	N/A	N/A	Flare Slope RT (%)	N/A
N/A	Flare Traversable LT?	N/A	N/A	Flare Traversable RT?	N/A
N/A	Landing Length (in)	N/A	N/A	DWS Provided?	N/A
N/A	Landing Width (in)	N/A	N/A	DWS Contrast?	N/A
N/A	Landing Slope (%)	N/A	N/A	DWS Length (in)	N/A
N/A	Landing X Slope (%)	N/A	N/A	DWS Full Width?	N/A
N/A	Landing Curb? (Y/N)	N/A	N/A	DWS Offset (in)	N/A
N/A	Shared Landing?	N/A			
N/A	Gutter Ponding?	N/A	N/A	Gutter Slope (%)	N/A
N/A	Gutter Lip Ht (in)	N/A	N/A	Gutter X Slope (%)	N/A
N/A	Painted X Walk1?	No	N/A	Painted X Walk2?	No
	X Walk 1 Direction	To NW		X Walk 2 Direction	To SW
	X Walk 1 Width (in)	N/A		X Walk 2 Width (in)	N/A
	X Walk 1 Slope (%)	1.1		X Walk 2 Slope (%)	3.2
	X Walk 1 X Slope (%)	4.5		X Walk 2 X Slope (%)	1.7

N/A	Ramp inside XWalk1?	N/A	N/A	Ramp inside XWalk2?	N/A
	Road Slope (%)	4.1		Clear Space?	N/A
	Road X Slope (%)	0.2	N/A	Clear Space to XWalk (in)	N/A
N/A	Any Obstructions?	N/A	N/A	Storm Grate/Utility Hazard?	N/A
	Obstruction Type			Storm Grate/Utility Type	
		N/A			N/A
			Yes	Surface Condition? (G/P)	Good
			No	Curb Slope (%)	9.1

Remove & Replace Curb Ramp With Two New Directional Ramps or Equivalent.

Total Cost: \$ 3200.00
