Access Compliance Report Public Rights-of-Way (Curb Ramps)

Intersection ID: 12706Main Street:KILBORNE_DRCross Street:WICKLOW_PLLocation:NEADA ID: AE3C7B25C286Ramp Type:PerpInitial Pass/Fail:FailOverall Compliance:NoSeverity Score:22.5

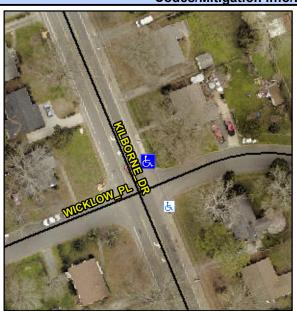
Field Measurements/Component Compliance							
Comp	oliance Description	Data	Comp	liance Description	Data		
N/A	Ramp Length (in)	57.0	No	Ramp Slope (%)	9.0		
No	Ramp Width (in)	44.0	No	Ramp XSlope (%)	3.3		
N/A	Flare Type LT	N/A	N/A	Flare Type RT	N/A		
N/A	Flare Slope LT (%)	N/A	N/A	Flare Slope RT (%)	N/A		
N/A	Flare Traversable LT?	N/A	N/A	Flare Traversable RT?	N/A		
N/A	Landing Length (in)	N/A	N/A	DWS Provided?	N/A		
N/A	Landing Width (in)	N/A	N/A	DWS Contrast?	N/A		
N/A	Landing Slope (%)	N/A	N/A	DWS Length (in)	N/A		
N/A	Landing X Slope (%)	N/A	N/A	DWS Full Width?	N/A		
N/A	Landing Curb? (Y/N)	N/A	N/A	DWS Offset (in)	N/A		
N/A	Shared Landing?	N/A					
N/A	Gutter Ponding?	N/A	N/A	Gutter Slope (%)	N/A		
N/A	Gutter Lip Ht (in)	N/A	N/A	Gutter X Slope (%)	N/A		
N/A	Painted X Walk1?	No	N/A	Painted X Walk2?	N/A		
	X Walk 1 Direction	To S		X Walk 2 Direction	N/A		
N/A	X Walk 1 Width (in)	N/A	N/A	X Walk 2 Width (in)	N/A

X Walk 1 Slope (%)	0.2		X Walk 2 Slope (%)	N/A		
	X Walk 1 X Slope (%)	4.4		X Walk 2 X Slope (%)	N/A		
N/A	Ramp inside XWalk1?	N/A	N/A	Ramp inside XWalk2?	N/A		
	Road Slope (%)	N/A	N/A	Clear Space?	N/A		
	Road X Slope (%)	N/A	N/A	Clear Space to XWalk (in)	N/A		
N/A	Any Obstructions?	N/A	N/A	Storm Grate/Utility Hazard?	N/A		
	Obstruction Type			Storm Grate/Utility Type			
		N/A			N/A		
			Yes	Surface Condition? (G/P)	Good		
/ ///		,	•	. ,

Possible Solutions:	<u>c</u>
Remove & Replace Entire Ramp.	N
	N
	N
	N.
	N
	N
Surveyor Notes:	N
N/A	N
	N
	N
	N
PROW/ADA:	N
Not Found, R304.5.1, R304.2.2,	N
R304.5.3	N
	N
	N.

Total Cost: \$ 1850.00
