Access Compliance Report

Public Rights-of-Way

(Curb Ramps)

Intersection ID: 50610	Main Street: GOLDEN_WOOD_LN	Cross Street: DOWNY_BIRCH_RD	Location: NW
ADA ID: AE48A3BDC656	Ramp Type: Perp	Initial Pass/Fail: Fail	Overall Compliance: No
Severity Score: 22.5			
Codes/Mitigation Info/Possible Solution		Field Measurements/Component Compliance

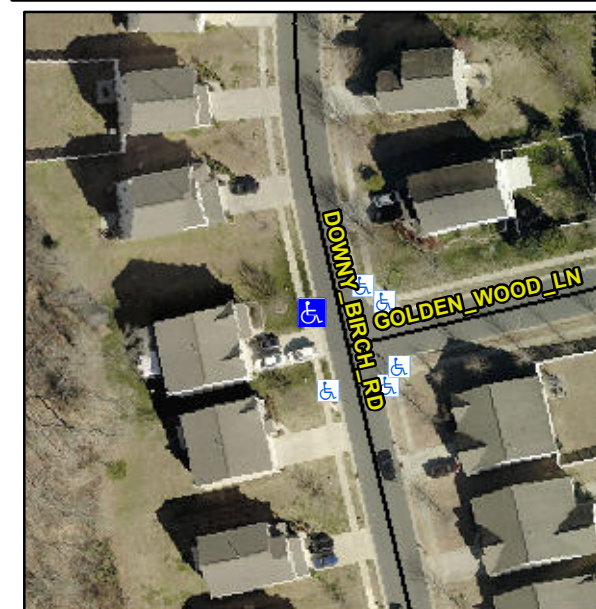
Not Found, R304.5.1, R304.2.2, R304.5.3

Compliance	Description	Data	Compliance	Description	Data
N/A	Ramp Length (in)	47.0	No	Ramp Slope (%)	9.9
No	Ramp Width (in)	47.0	No	Ramp XSlope (%)	3.3
N/A	Flare Type LT	N/A	N/A	Flare Type RT	N/A
N/A	Flare Slope LT (%)	N/A	N/A	Flare Slope RT (%)	N/A
N/A	Flare Traversable LT?	N/A	N/A	Flare Traversable RT?	N/A
N/A	Landing Length (in)	N/A	N/A	DWS Provided?	N/A
N/A	Landing Width (in)	N/A	N/A	DWS Contrast?	N/A
N/A	Landing Slope (%)	N/A	N/A	DWS Length (in)	N/A
N/A	Landing X Slope (%)	N/A	N/A	DWS Full Width?	N/A
N/A	Landing Curb? (Y/N)	N/A	N/A	DWS Offset (in)	N/A
N/A	Shared Landing?	N/A			
N/A	Gutter Ponding?	N/A	N/A	Gutter Slope (%)	N/A
N/A	Gutter Lip Ht (in)	N/A	N/A	Gutter X Slope (%)	N/A
N/A	Painted X Walk1?	No	N/A	Painted X Walk2?	N/A
	X Walk 1 Direction	To E		X Walk 2 Direction	N/A
N/A	X Walk 1 Width (in)	N/A	N/A	X Walk 2 Width (in)	N/A
	X Walk 1 Slope (%)	3.9		X Walk 2 Slope (%)	N/A
	X Walk 1 X Slope (%)	3.8		X Walk 2 X Slope (%)	N/A

N/A	Ramp inside XWalk1?	N/A	N/A	Ramp inside XWalk2?	N/A
	Road Slope (%)	N/A	N/A	Clear Space?	N/A
	Road X Slope (%)	N/A	N/A	Clear Space to XWalk (in)	N/A
N/A	Any Obstructions?	N/A	N/A	Storm Grate/Utility Hazard?	N/A
	Obstruction Type			Storm Grate/Utility Type	
		N/A			N/A
			Yes	Surface Condition? (G/P)	Good

Possible Solutions:

Remove & Replace Entire Ramp.
