Access Compliance Report

Public Rights-of-Way

(Curb Ramps)

Intersection ID: 10037289	Main Street: SARDIS_RD_NORTH	Cross Street: N/A	Location: SW
ADA ID: AE4D67748B7B	Ramp Type: Perp	Initial Pass/Fail: Fail	Overall Compliance: No
Severity Score: 21.25			
Codes/Mitigation Info/Possible Solution		Field Measurements/Component Compliance

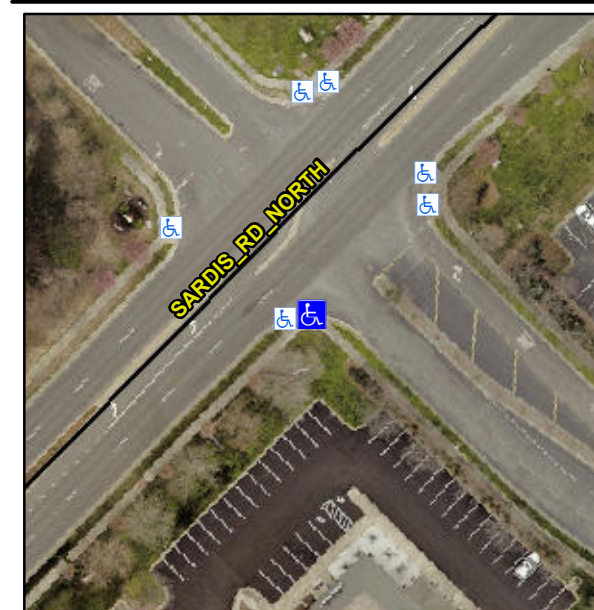
Not Found, R304.5.1, R304.2.2

Compliance	Description	Data	Compliance	Description	Data
N/A	Ramp Length (in)	76.0	No	Ramp Slope (%)	8.6
No	Ramp Width (in)	36.0	Yes	Ramp XSlope (%)	1.4
N/A	Flare Type LT	N/A	N/A	Flare Type RT	N/A
N/A	Flare Slope LT (%)	N/A	N/A	Flare Slope RT (%)	N/A
N/A	Flare Traversable LT?	N/A	N/A	Flare Traversable RT?	N/A
N/A	Landing Length (in)	N/A	N/A	DWS Provided?	N/A
N/A	Landing Width (in)	N/A	N/A	DWS Contrast?	N/A
N/A	Landing Slope (%)	N/A	N/A	DWS Length (in)	N/A
N/A	Landing X Slope (%)	N/A	N/A	DWS Full Width?	N/A
N/A	Landing Curb? (Y/N)	N/A	N/A	DWS Offset (in)	N/A
N/A	Shared Landing?	N/A			
N/A	Gutter Ponding?	N/A	N/A	Gutter Slope (%)	N/A
N/A	Gutter Lip Ht (in)	N/A	N/A	Gutter X Slope (%)	N/A
N/A	Painted X Walk1?	No	N/A	Painted X Walk2?	N/A
	X Walk 1 Direction	To NE		X Walk 2 Direction	N/A
N/A	X Walk 1 Width (in)	N/A	N/A	X Walk 2 Width (in)	N/A
	X Walk 1 Slope (%)	0.3		X Walk 2 Slope (%)	N/A
	X Walk 1 X Slope (%)	2.2		X Walk 2 X Slope (%)	N/A

N/A	Ramp inside XWalk1?	N/A	N/A	Ramp inside XWalk2?	N/A
	Road Slope (%)	N/A	N/A	Clear Space?	N/A
	Road X Slope (%)	N/A	N/A	Clear Space to XWalk (in)	N/A
N/A	Any Obstructions?	N/A	N/A	Storm Grate/Utility Hazard?	N/A
	Obstruction Type			Storm Grate/Utility Type	
		N/A			N/A
			Yes	Surface Condition? (G/P)	Good

Possible Solutions:

Remove & Replace Entire Ramp.
