Access Compliance Report

Public Rights-of-Way

(Curb Ramps)

Intersection ID: 12728	Main Street: E_10TH_ST	Cross Street: SEIGLE_AV	Location: E
ADA ID: AE5094BB56DE	Ramp Type: PerpDiag	Initial Pass/Fail: Fail	Overall Compliance: No
		Severity Score: 37.5

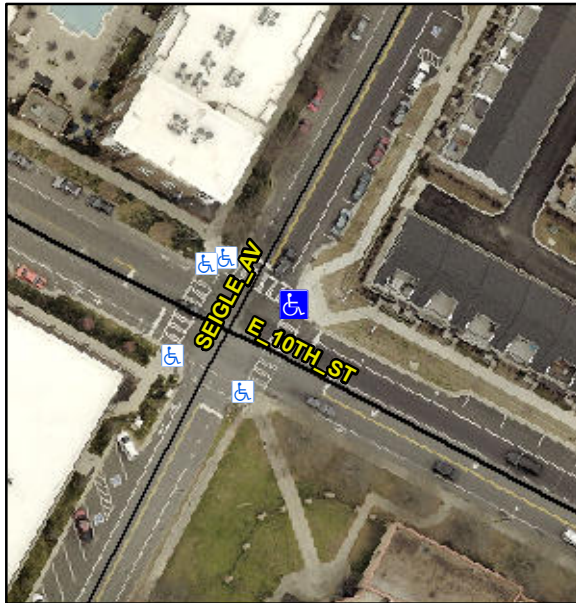
Compliance	Description	Data	Compliance	Description	Data
N/A	Ramp Length (in)	52.0	No	Ramp Slope (%)	12.1
Yes	Ramp Width (in)	60.0	No	Ramp XSlope (%)	6.4
N/A	Flare Type LT	N/A	N/A	Flare Type RT	N/A
N/A	Flare Slope LT (%)	N/A	N/A	Flare Slope RT (%)	N/A
N/A	Flare Traversable LT?	N/A	N/A	Flare Traversable RT?	N/A
N/A	Landing Length (in)	N/A	N/A	DWS Provided?	N/A
N/A	Landing Width (in)	N/A	N/A	DWS Contrast?	N/A
N/A	Landing Slope (%)	N/A	N/A	DWS Length (in)	N/A
N/A	Landing X Slope (%)	N/A	N/A	DWS Full Width?	N/A
N/A	Landing Curb? (Y/N)	N/A	N/A	DWS Offset (in)	N/A
N/A	Shared Landing?	N/A			
N/A	Gutter Ponding?	N/A	N/A	Gutter Slope (%)	N/A
N/A	Gutter Lip Ht (in)	N/A	N/A	Gutter X Slope (%)	N/A
N/A	Painted X Walk1?	Yes	N/A	Painted X Walk2?	Yes
	X Walk 1 Direction	To NW		X Walk 2 Direction	To SW
N/A	X Walk 1 Width (in)	94.5	N/A	X Walk 2 Width (in)	110.0
	X Walk 1 Slope (%)	1.9		X Walk 2 Slope (%)	5.6
	X Walk 1 X Slope (%)	2.7		X Walk 2 X Slope (%)	3.9

N/A	Ramp inside XWalk1?	Yes	N/A	Ramp inside XWalk2?	Yes
	Road Slope (%)	1.2	N/A	Clear Space?	N/A
	Road X Slope (%)	6.9	N/A	Clear Space to XWalk (in)	N/A
N/A	Any Obstructions?	N/A	N/A	Storm Grate/Utility Hazard?	N/A
	Obstruction Type			Storm Grate/Utility Type	
		N/A			N/A
		Yes		Surface Condition? (G/P)	Good

Remove & Replace Curb Ramp With Two New Directional Ramps or Equivalent.
