Intersection ID: 8095	Main Street: HOVIS_RD	Cross Street: WABASH_AV	Location:	S
ADA ID: AE50D01059B8	Ramp Type: Perp	Initial Pass/Fail: Fail	Overall Compliance: No	Severity Score: 17.5

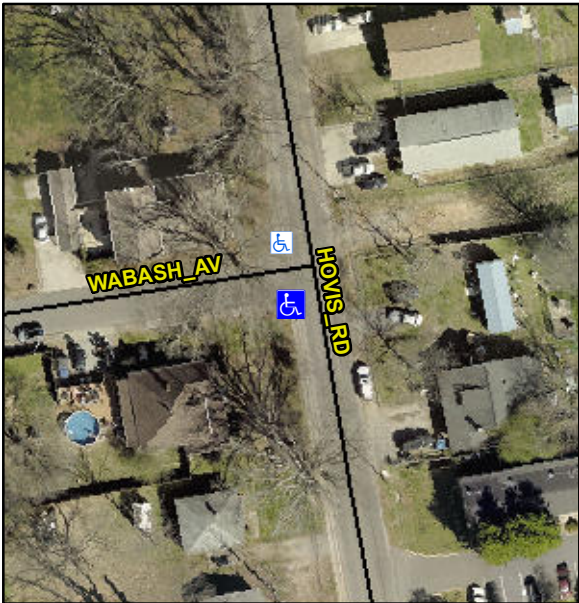
Possible Solutions:		Compliance	Description	Data	Compliance	Description	Data
	Remove & Replace Entire Ramp.		N/A	Ramp Length (in)	38.0	Yes	Ramp Slope (%)	6.1
			No	Ramp Width (in)	33.0	Yes	Ramp XSlope (%)	0.0
			N/A	Flare Type LT	N/A	N/A	Flare Type RT	N/A
			N/A	Flare Slope LT (%)	N/A	N/A	Flare Slope RT (%)	N/A
			N/A	Flare Traversable LT?	N/A	N/A	Flare Traversable RT?	N/A
			N/A	Landing Length (in)	N/A	N/A	DWS Provided?	N/A
			N/A	Landing Width (in)	N/A	N/A	DWS Contrast?	N/A
			N/A	Landing Slope (%)	N/A	N/A	DWS Length (in)	N/A
			N/A	Landing X Slope (%)	N/A	N/A	DWS Full Width?	N/A
Surveyor Notes:	N/A		N/A	Landing Curb? (Y/N)	N/A	N/A	DWS Offset (in)	N/A
			N/A	Shared Landing?	N/A			
			N/A	Gutter Ponding?	N/A	N/A	Gutter Slope (%)	N/A
			N/A	Gutter Lip Ht (in)	N/A	N/A	Gutter X Slope (%)	N/A
			N/A	Painted X Walk1?	No	N/A	Painted X Walk2?	N/A

X Walk 1 Direction	To N		X Walk 2 Direction	N/A
			N/A	X Walk 1 Width (in)	N/A	N/A	X Walk 2 Width (in)	N/A
				X Walk 1 Slope (%)	0.1		X Walk 2 Slope (%)	N/A
				X Walk 1 X Slope (%)	1.6		X Walk 2 X Slope (%)	N/A
			N/A	Ramp inside XWalk1?	N/A	N/A	Ramp inside XWalk2?	N/A
PROW/ADA:	R304.5.1			Road Slope (%)	N/A	N/A	Clear Space?	N/A
				Road X Slope (%)	N/A	N/A	Clear Space to XWalk (in)	N/A
			N/A	Any Obstructions?	N/A	N/A	Storm Grate/Utility Hazard?	N/A
				Obstruction Type			Storm Grate/Utility Type	
					N/A			N/A
						Yes	Surface Condition? (G/P)	Good
	Total Cost:		\$	1850.00
