Access Compliance Report

Public Rights-of-Way

(Curb Ramps)

Intersection ID: N/A	Main Street: E_3RD_ST	Cross Street: S_MCDOWELL_ST	Location: N
ADA ID: AE5F8ABE817C	Ramp Type: Perp	Initial Pass/Fail: Pass	Overall Compliance: No
Severity Score: 0			
Codes/Mitigation Info/Possible Solution		Field Measurements/Component Compliance

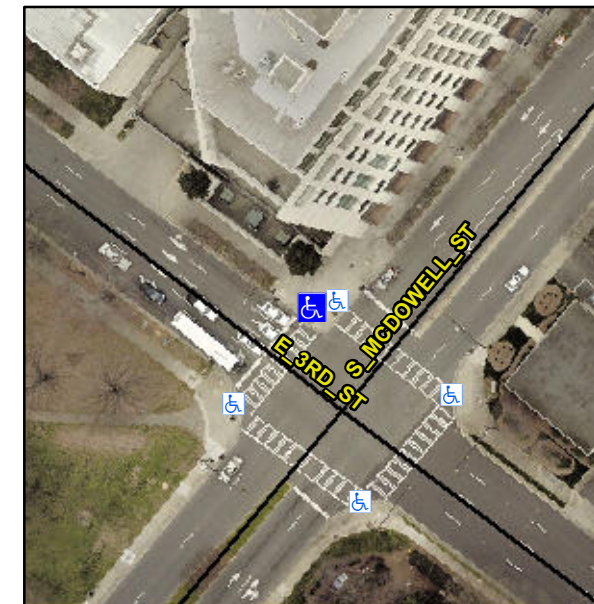
Compliance	Description	Data	Compliance	Description	Data
N/A	Ramp Length (in)	61.0	Yes	Ramp Slope (%)	7.7
Yes	Ramp Width (in)	48.0	Yes	Ramp XSlope (%)	0.5
N/A	Flare Type LT	Sloped	N/A	Flare Type RT	N/A
N/A	Flare Slope LT (%)	5.8	Yes	Flare Slope RT (%)	7.3
N/A	Flare Traversable LT?	Yes	N/A	Flare Traversable RT?	Yes
Yes	Landing Length (in)	60.0	Yes	DWS Provided?	Yes
Yes	Landing Width (in)	52.0	Yes	DWS Contrast?	Yes
No	Landing Slope (%)	2.8	Yes	DWS Length (in)	24.5
Yes	Landing X Slope (%)	1.1	Yes	DWS Full Width?	Yes
N/A	Landing Curb? (Y/N)	No	No	DWS Offset (in)	3.5
N/A	Shared Landing?	No			
Yes	Gutter Ponding?	No	Yes	Gutter Slope (%)	3.4
Yes	Gutter Lip Ht (in)	0.0	Yes	Gutter X Slope (%)	0.8
N/A	Painted X Walk1?	Yes	N/A	Painted X Walk2?	N/A
	X Walk 1 Direction	To SW		X Walk 2 Direction	N/A
N/A	X Walk 1 Width (in)	106.0	N/A	X Walk 2 Width (in)	N/A
	X Walk 1 Slope (%)	1.6		X Walk 2 Slope (%)	N/A
	X Walk 1 X Slope (%)	1.0		X Walk 2 X Slope (%)	N/A

Yes	Ramp inside XWalk1?	Yes	N/A	Ramp inside XWalk2?	N/A
	Road Slope (%)	N/A	N/A	Clear Space?	Yes
	Road X Slope (%)	N/A	N/A	Clear Space to XWalk (in)	N/A
Yes	Any Obstructions?	No	Yes	Storm Grate/Utility Hazard?	No
	Obstruction Type			Storm Grate/Utility Type	
		N/A			N/A
			Yes	Surface Condition? (G/P)	Good

Possible Solutions:

Remove & Replace Entire Ramp.

R304.2.2-Perp, R304.3.2-Para, R305.2
