Access Compliance Report Public Rights-of-Way (Curb Ramps)

Intersection ID: 10014519 Main Street: UNIVERSITY_POINTE_BV Cross Street: N/A Location: NW
ADA ID: AE60BCD1AF29 Ramp Type: Perp Initial Pass/Fail: Fail Overall Compliance: No Severity Score: 13.75

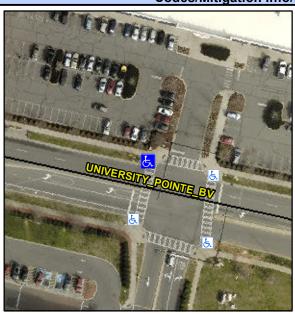
/Possible Solution			Field Measurements/Component Compliance						
Possible Solutions:			Comp	liance Description	Data	Compl	iance	Description	Data
Remove & Replace Entire I	Ram	p.	N/A	Ramp Length (in)	95.0	No	Ramp	Slope (%)	9.2
·		•	Yes	Ramp Width (in)	48.0	No	Ramp	XSlope (%)	3.6
1			N/A	Flare Type LT	N/A	N/A	Flare	Type RT	N/A
			N/A	Flare Slope LT (%)	N/A	N/A	Flare	Slope RT (%)	N/A
			N/A	Flare Traversable LT?	N/A	N/A	Flare	Traversable RT?	N/A
			N/A	Landing Length (in)	N/A	N/A	DWS	Provided?	N/A
Surveyor Notes:			N/A	Landing Width (in)	N/A	N/A	DWS	Contrast?	N/A
N/A			N/A	Landing Slope (%)	N/A	N/A	DWS	Length (in)	N/A
			N/A	Landing X Slope (%)	N/A	N/A	DWS	Full Width?	N/A
			N/A	Landing Curb? (Y/N)	N/A	N/A	DWS	Offset (in)	N/A
			N/A	Shared Landing?	N/A				
PROW/ADA:			N/A	Gutter Ponding?	N/A	N/A	Gutte	r Slope (%)	N/A
R304.2.2, R304.5.3			N/A	Gutter Lip Ht (in)	N/A	N/A	Gutte	r X Slope (%)	N/A
ŕ			N/A	Painted X Walk1?	Yes	N/A	Paint	ed X Walk2?	N/A

X Walk 1 Direction	To S		X Wa	lk 2 Direction	N/A
			N/A	X Walk 1 Width (in)	107.0	N/A	X Wa	lk 2 Width (in)	N/A
				X Walk 1 Slope (%)	0.6		X Wa	lk 2 Slope (%)	N/A
				X Walk 1 X Slope (%)	2.4		X Wa	lk 2 X Slope (%)	N/A
			N/A	Ramp inside XWalk1?	Yes	N/A	Ram	inside XWalk2?	N/A
				Road Slope (%)	N/A	N/A	Clear	Space?	N/A
				Road X Slope (%)	N/A	N/A	Clear	Space to XWalk (in)	N/A
			N/A	Any Obstructions?	N/A	N/A	Storn	n Grate/Utility Hazard?	N/A
Total Cost:	\$	1850.00		Obstruction Type		l	Storn	n Grate/Utility Type	
					N/A				N/A
