Access Compliance Report

Public Rights-of-Way

(Curb Ramps)

Intersection ID: 30054	Main Street: DAY_LILLY_LN	Cross Street: SOUTHWIND_DR	Location: NE
ADA ID: AE6237956819	Ramp Type: PerpDiag	Initial Pass/Fail: Fail	Overall Compliance: No
		Severity Score: 25

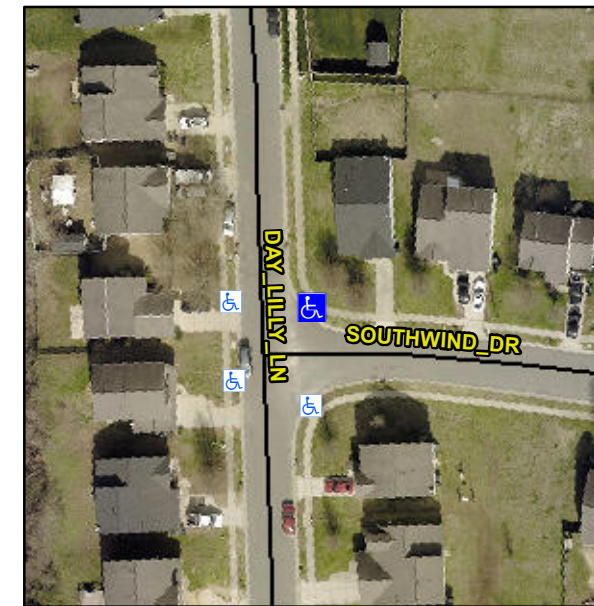
Compliance	Description	Data	Compliance	Description	Data
N/A	Ramp Length (in)	47.0	No	Ramp Slope (%)	11.2
Yes	Ramp Width (in)	48.0	No	Ramp XSlope (%)	5.4
N/A	Flare Type LT	N/A	N/A	Flare Type RT	N/A
N/A	Flare Slope LT (%)	N/A	N/A	Flare Slope RT (%)	N/A
N/A	Flare Traversable LT?	N/A	N/A	Flare Traversable RT?	N/A
N/A	Landing Length (in)	N/A	N/A	DWS Provided?	N/A
N/A	Landing Width (in)	N/A	N/A	DWS Contrast?	N/A
N/A	Landing Slope (%)	N/A	N/A	DWS Length (in)	N/A
N/A	Landing X Slope (%)	N/A	N/A	DWS Full Width?	N/A
N/A	Landing Curb? (Y/N)	N/A	N/A	DWS Offset (in)	N/A
N/A	Shared Landing?	N/A			
N/A	Gutter Ponding?	N/A	N/A	Gutter Slope (%)	N/A
N/A	Gutter Lip Ht (in)	1.0	N/A	Gutter X Slope (%)	N/A
N/A	Painted X Walk1?	No	N/A	Painted X Walk2?	No
	X Walk 1 Direction	To W		X Walk 2 Direction	To S
N/A	X Walk 1 Width (in)	N/A	N/A	X Walk 2 Width (in)	N/A
	X Walk 1 Slope (%)	1.4		X Walk 2 Slope (%)	0.2
	X Walk 1 X Slope (%)	0.6		X Walk 2 X Slope (%)	1.5

N/A	Ramp inside XWalk1?	N/A	N/A	Ramp inside XWalk2?	N/A
	Road Slope (%)	3.6	N/A	Clear Space?	N/A
	Road X Slope (%)	2.7	N/A	Clear Space to XWalk (in)	N/A
N/A	Any Obstructions?	N/A	N/A	Storm Grate/Utility Hazard?	N/A
	Obstruction Type			Storm Grate/Utility Type	
		N/A			N/A
			Yes	Surface Condition? (G/P)	Good

Possible Solutions:

Remove & Replace Curb Ramp With Two New Directional Ramps or Equivalent.

R304.2.2, R304.5.3
