# Access Compliance Report

## Public Rights-of-Way

| Intersection ID: 52448 | Main Street: WOODWARD_AV | Cross Street: DOUBLE_OAKS_RD | Location: SW |
| ADA ID: AE64A10C4D92 | Ramp Type: Directional1 | Initial Pass/Fail: Pass | Overall Compliance: No |

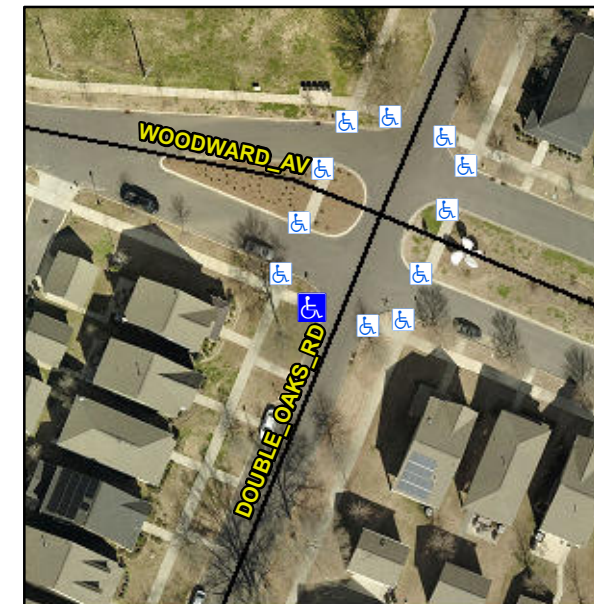
**R304.5.3, R304.2.2-Perp, R304.3.2-  
Para, R302.7.2**

| Compliance | Description | Data | Compliance | Description | Data |
|---|---|---|---|---|---|
| Yes | Ramp Slope (%) | 3.2 | No | Grade Break XSlope (%) | 2.8 |
| No | Ramp XSlope (%) | 2.7 | | | |
| No | Landing Slope (%) | 2.3 | Yes | DWS Length (in) | 24.0 |
| No | Landing X Slope (%) | 2.3 | Yes | DWS Full Width? | Yes |
| No | Gutter Lip Ht (in) | 1.0 | Yes | Gutter X Slope (%) | 0.3 |

**Remove & Replace Entire Ramp.  
Grind Gutter Lip.**
