Access Compliance Report

Public Rights-of-Way (Curb Ramps)

Intersection ID: 20181	Main Street: ABERDALE_WY	Cross Street: COLLINGHAM_DR	Location: SE
ADA ID: AE65E3CF1CFA	Ramp Type: Directional1	Initial Pass/Fail: Fail	Overall Compliance: No
Codes/Mitigation Info/Possible Solution			Severity Score: 10
			Field Measurements/Component Compliance

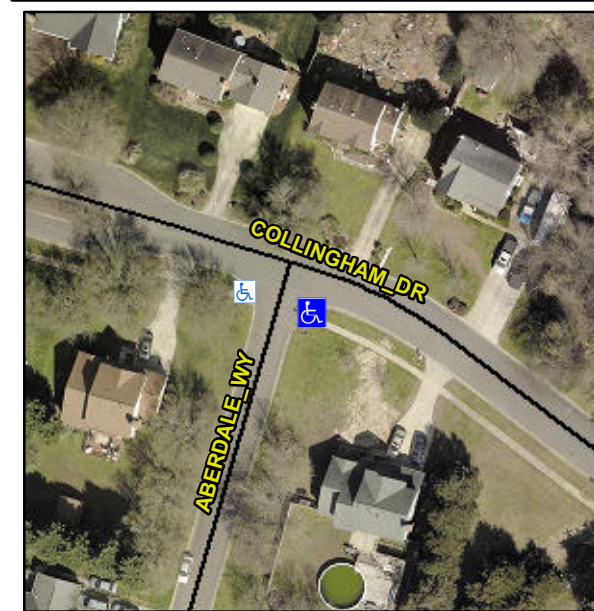
Compliance	Description	Data	Compliance	Description	Data
N/A	Ramp Length (in)	76.0	N/A	Grade Break?	N/A
No	Ramp Width (in)	45.0	N/A	Grade Break Slope (%)	0.0
Yes	Ramp Slope (%)	5.7	N/A	Grade Break XSlope (%)	0.0
No	Ramp XSlope (%)	2.1			
N/A	Flare Type LT	N/A	N/A	Flare Type RT	N/A
N/A	Flare Slope LT (%)	N/A	N/A	Flare Slope RT (%)	0.0
N/A	Flare Traversable LT?	N/A	N/A	Flare Traversable RT?	N/A
N/A	Landing Length (in)	0.0	N/A	DWS Provided?	N/A
N/A	Landing Width (in)	0.0	N/A	DWS Contrast?	N/A
N/A	Landing Slope (%)	0.0	N/A	DWS Length (in)	N/A
N/A	Landing X Slope (%)	0.0	N/A	DWS Full Width?	N/A
N/A	Landing Curb? (Y/N)	N/A	N/A	DWS Offset LT (in)	N/A
N/A	Shared Landing?	N/A	N/A	DWS Offset RT (in)	N/A
N/A	Gutter Ponding?	0.0	N/A	Gutter Slope (%)	N/A
N/A	Gutter Lip Ht (in)	0.0	N/A	Gutter X Slope (%)	N/A
N/A	Painted X Walk1?	No		Road Slope (%)	4.1
	X Walk 1 Direction	To W		Road X Slope (%)	2.5
	X Walk 1 Width (in)	N/A		Clear Space?	N/A

X Walk 1 Slope (%)	4.1	N/A	Clear Space to XWalk (in)	N/A
	X Walk 1 X Slope (%)	2.5	N/A	Storm Grate/Utility Hazard?	N/A
N/A	Ramp inside XWalk1?	N/A		Storm Grate/Utility Type	
N/A	Any Obstructions?	N/A			N/A
	Obstruction Type		Yes	Surface Condition? (G/P)	Good
			N/A	Curb Slope (%)	12.1

Remove & Replace Entire Ramp.
