# Access Compliance Report

## Public Rights-of-Way

### (Curb Ramps)

Intersection ID: 11847	Main Street: E_9TH_ST	Cross Street: N_TRYON_ST	Location: S
ADA ID: AE7085CF814D	Ramp Type: Perp	Initial Pass/Fail: Fail	Overall Compliance: No
Severity Score: 12.5			
Codes/Mitigation Info/Possible Solution		Field Measurements/Component Compliance

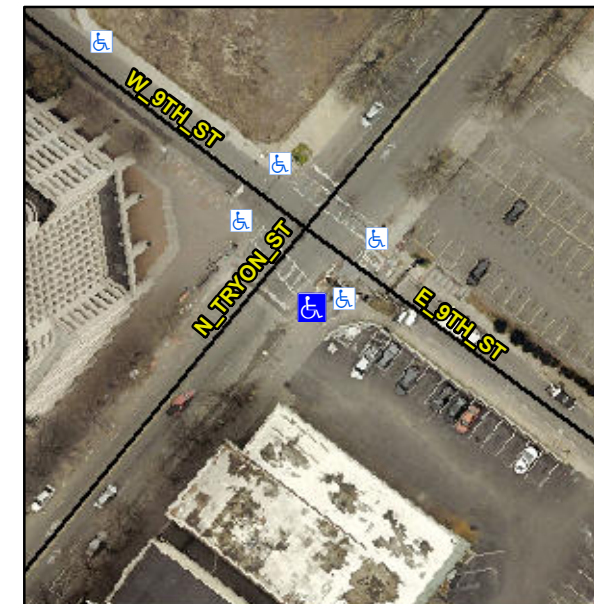
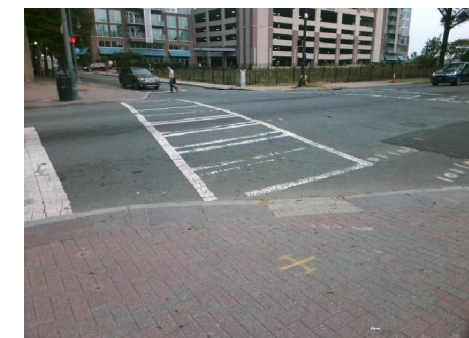
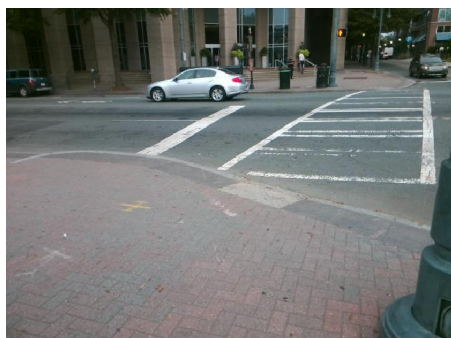
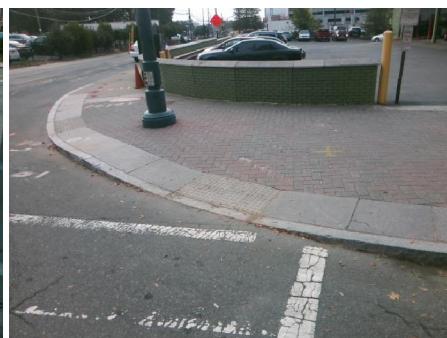
Compliance	Description	Data	Compliance	Description	Data
N/A	Ramp Length (in)	84.0	No	Ramp Slope (%)	10.2
Yes	Ramp Width (in)	48.0	Yes	Ramp XSlope (%)	0.5
N/A	Flare Type LT	N/A	N/A	Flare Type RT	N/A
N/A	Flare Slope LT (%)	N/A	N/A	Flare Slope RT (%)	N/A
N/A	Flare Traversable LT?	N/A	N/A	Flare Traversable RT?	N/A
N/A	Landing Length (in)	N/A	N/A	DWS Provided?	N/A
N/A	Landing Width (in)	N/A	N/A	DWS Contrast?	N/A
N/A	Landing Slope (%)	N/A	N/A	DWS Length (in)	N/A
N/A	Landing X Slope (%)	N/A	N/A	DWS Full Width?	N/A
N/A	Landing Curb? (Y/N)	N/A	N/A	DWS Offset (in)	N/A
N/A	Shared Landing?	N/A			
N/A	Gutter Ponding?	N/A	N/A	Gutter Slope (%)	N/A
N/A	Gutter Lip Ht (in)	N/A	N/A	Gutter X Slope (%)	N/A
N/A	Painted X Walk1?	Yes	N/A	Painted X Walk2?	N/A
	X Walk 1 Direction	To NW		X Walk 2 Direction	N/A
N/A	X Walk 1 Width (in)	120.0	N/A	X Walk 2 Width (in)	N/A
	X Walk 1 Slope (%)	6.9		X Walk 2 Slope (%)	N/A
	X Walk 1 X Slope (%)	2.6		X Walk 2 X Slope (%)	N/A

N/A	Ramp inside XWalk1?	Yes	N/A	Ramp inside XWalk2?	N/A
	Road Slope (%)	N/A	N/A	Clear Space?	N/A
	Road X Slope (%)	N/A	N/A	Clear Space to XWalk (in)	N/A
N/A	Any Obstructions?	N/A	N/A	Storm Grate/Utility Hazard?	N/A
	Obstruction Type			Storm Grate/Utility Type	
		N/A			N/A
		Yes		Surface Condition? (G/P)	Good

**Remove & Replace Entire Ramp.**

**R304.2.2**
