# Access Compliance Report

## Public Rights-of-Way

### (Curb Ramps)

Intersection ID: 10024053	Main Street: CORONATION_BV	Cross Street: N/A	Location: E
ADA ID: AE718EF138EF	Ramp Type: PerpDiag	Initial Pass/Fail: Fail	Overall Compliance: No
Codes/Mitigation Info/Possible Solution		Field Measurements/Component Compliance	
Severity Score: 12.5

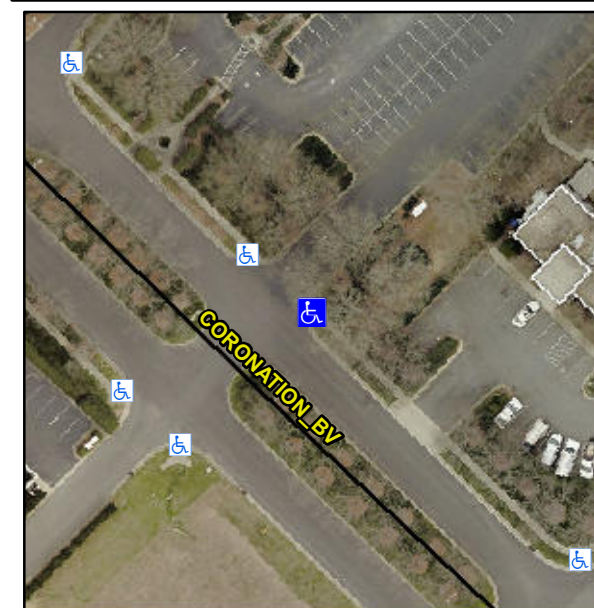
**Not Found, R304.5.3**

Compliance	Description	Data	Compliance	Description	Data
N/A	Ramp Length (in)	91.0	Yes	Ramp Slope (%)	6.7
Yes	Ramp Width (in)	48.0	No	Ramp XSlope (%)	5.3
N/A	Flare Type LT	N/A	N/A	Flare Type RT	N/A
N/A	Flare Slope LT (%)	N/A	N/A	Flare Slope RT (%)	N/A
N/A	Flare Traversable LT?	N/A	N/A	Flare Traversable RT?	N/A
N/A	Landing Length (in)	N/A	N/A	DWS Provided?	N/A
N/A	Landing Width (in)	N/A	N/A	DWS Contrast?	N/A
N/A	Landing Slope (%)	N/A	N/A	DWS Length (in)	N/A
N/A	Landing X Slope (%)	N/A	N/A	DWS Full Width?	N/A
N/A	Landing Curb? (Y/N)	N/A	N/A	DWS Offset (in)	N/A
N/A	Shared Landing?	N/A			
N/A	Gutter Ponding?	N/A	N/A	Gutter Slope (%)	N/A
N/A	Gutter Lip Ht (in)	N/A	N/A	Gutter X Slope (%)	N/A
N/A	Painted X Walk1?	No	N/A	Painted X Walk2?	No
	X Walk 1 Direction	To NW		X Walk 2 Direction	To SW
N/A	X Walk 1 Width (in)	N/A	N/A	X Walk 2 Width (in)	N/A
	X Walk 1 Slope (%)	3.5		X Walk 2 Slope (%)	1.4
	X Walk 1 X Slope (%)	7.2		X Walk 2 X Slope (%)	2.6

N/A	Ramp inside XWalk1?	N/A	N/A	Ramp inside XWalk2?	N/A
	Road Slope (%)	4.9	N/A	Clear Space?	N/A
	Road X Slope (%)	6.8	N/A	Clear Space to XWalk (in)	N/A
N/A	Any Obstructions?	N/A	N/A	Storm Grate/Utility Hazard?	N/A
	Obstruction Type			Storm Grate/Utility Type	
		N/A			N/A
			Yes	Surface Condition? (G/P)	Good

Possible Solutions:

**Remove & Replace Curb Ramp With Two New Directional Ramps or Equivalent.**
