Access Compliance Report

Public Rights-of-Way

(Curb Ramps)

Intersection ID: 17062	Main Street: IDLEWILD_RD	Cross Street: MONROE_RD	Location: SE
ADA ID: AE7878E2CFB0	Ramp Type: PerpDiag	Initial Pass/Fail: Fail	Overall Compliance: No
Severity Score: 12.5			
Codes/Mitigation Info/Possible Solution		Field Measurements/Component Compliance

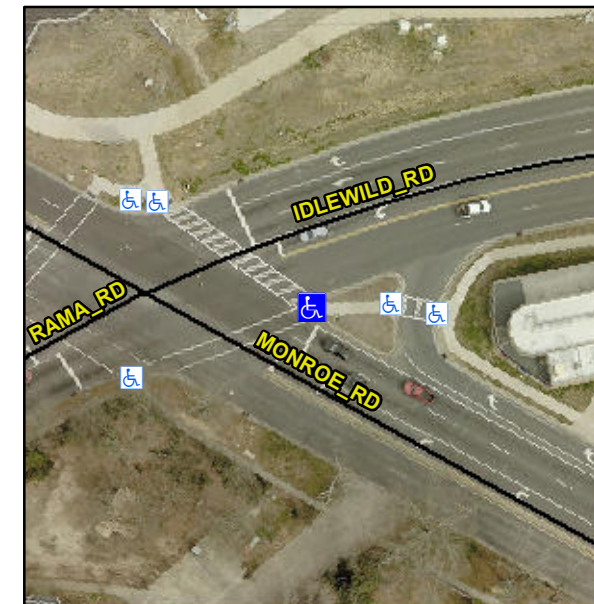
Not Found, R304.2.2

Compliance	Description	Data	Compliance	Description	Data
N/A	Ramp Length (in)	96.0	No	Ramp Slope (%)	10.2
Yes	Ramp Width (in)	77.0	Yes	Ramp XSlope (%)	0.5
N/A	Flare Type LT	N/A	N/A	Flare Type RT	N/A
N/A	Flare Slope LT (%)	N/A	N/A	Flare Slope RT (%)	N/A
N/A	Flare Traversable LT?	N/A	N/A	Flare Traversable RT?	N/A
N/A	Landing Length (in)	N/A	N/A	DWS Provided?	N/A
N/A	Landing Width (in)	N/A	N/A	DWS Contrast?	N/A
N/A	Landing Slope (%)	N/A	N/A	DWS Length (in)	N/A
N/A	Landing X Slope (%)	N/A	N/A	DWS Full Width?	N/A
N/A	Landing Curb? (Y/N)	N/A	N/A	DWS Offset (in)	N/A
N/A	Shared Landing?	N/A			
N/A	Gutter Ponding?	N/A	N/A	Gutter Slope (%)	N/A
N/A	Gutter Lip Ht (in)	N/A	N/A	Gutter X Slope (%)	N/A
N/A	Painted X Walk1?	Yes	N/A	Painted X Walk2?	Yes
	X Walk 1 Direction	To NW		X Walk 2 Direction	To SW
N/A	X Walk 1 Width (in)	128.0	N/A	X Walk 2 Width (in)	86.0
	X Walk 1 Slope (%)	0.7		X Walk 2 Slope (%)	1.3
	X Walk 1 X Slope (%)	1.6		X Walk 2 X Slope (%)	1.8

Remove & Replace Curb Ramp With Two New Directional Ramps or Equivalent.

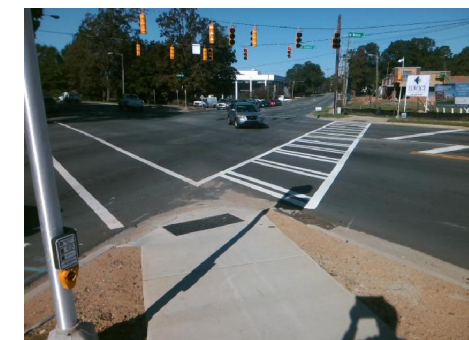
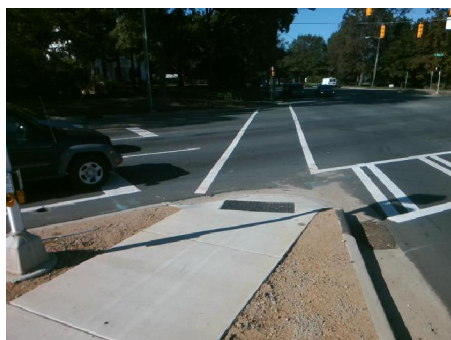
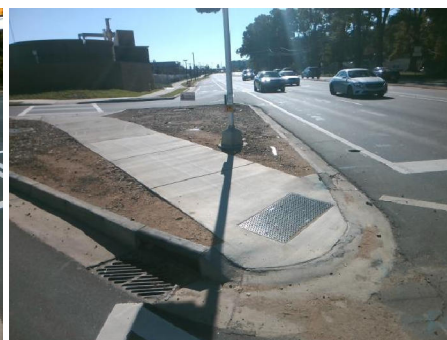
N/A	Ramp inside XWalk1?	Yes	N/A	Ramp inside XWalk2?	Yes
	Road Slope (%)	1.1	N/A	Clear Space?	N/A
	Road X Slope (%)	1.2	N/A	Clear Space to XWalk (in)	N/A
N/A	Any Obstructions?	N/A	N/A	Storm Grate/Utility Hazard?	N/A
	Obstruction Type			Storm Grate/Utility Type	
		N/A			N/A
		Yes		Surface Condition? (G/P)	Good
