# Access Compliance Report

## Public Rights-of-Way

### (Curb Ramps)

Intersection ID: 43182	Main Street: PATTONSBURG_DR	Cross Street: RAVANNA_DR	Location:	N
ADA ID: AE80C7D18A9F	Ramp Type: BlendTrans1	Initial Pass/Fail: Fail	Overall Compliance: No	Severity Score: 10
Codes/Mitigation Info/Possible Solution		Field Measurements/Component Compliance

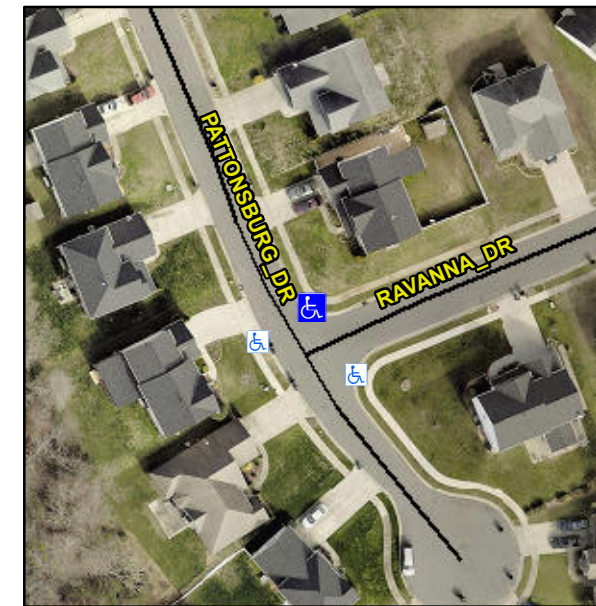
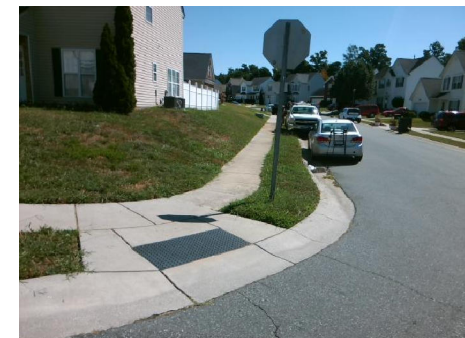
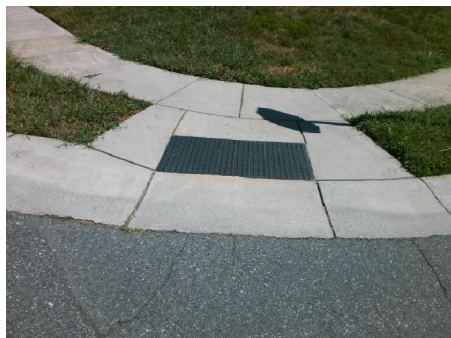
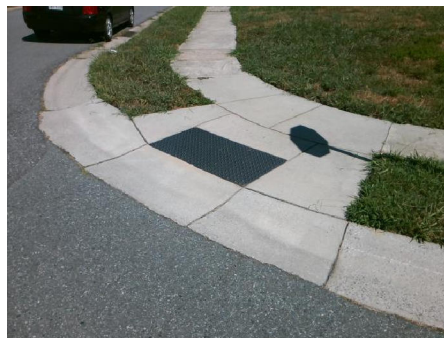
**Not Found, R304.5.1, R304.5.3**

Compliance	Description	Data	Compliance	Description	Data
N/A	Ramp Length (in)	46.0	Yes	BlendTrans Slope (%)	4.5
No	Ramp Width (in)	45.5	No	BlendTrans XSlope (%)	3.4
N/A	Flare Type LT	N/A	N/A	Flare Type RT	N/A
N/A	Flare Slope LT (%)	N/A	N/A	Flare Slope RT (%)	N/A
N/A	Flare Traversable LT?	N/A	N/A	Flare Traversable RT?	N/A
N/A	Landing Length (in)	N/A	N/A	DWS Provided?	N/A
N/A	Landing Width (in)	N/A	N/A	DWS Contrast?	N/A
N/A	Landing Slope (%)	N/A	N/A	DWS Length (in)	N/A
N/A	Landing X Slope (%)	N/A	N/A	DWS Full Width?	N/A
N/A	Landing Curb? (Y/N)	N/A	N/A	DWS Offset (in)	N/A
N/A	Shared Landing?	N/A			
N/A	Gutter Ponding?	N/A	N/A	Gutter Slope (%)	N/A
N/A	Gutter Lip Ht (in)	N/A	N/A	Gutter X Slope (%)	N/A
N/A	Painted X Walk1?	No	N/A	Painted X Walk2?	No
	X Walk 1 Direction	To W		X Walk 2 Direction	To E
	X Walk 1 Width (in)	N/A		X Walk 2 Width (in)	N/A
	X Walk 1 Slope (%)	5.5		X Walk 2 Slope (%)	3.7
	X Walk 1 X Slope (%)	5.1		X Walk 2 X Slope (%)	3.1

N/A	Ramp inside XWalk1?	N/A	N/A	Ramp inside XWalk2?	N/A
	Road Slope (%)	3.5		Clear Space?	N/A
	Road X Slope (%)	3.3	N/A	Clear Space to XWalk (in)	N/A
N/A	Any Obstructions?	N/A	N/A	Storm Grate/Utility Hazard?	N/A
	Obstruction Type			Storm Grate/Utility Type	
		N/A			N/A
			Yes	Surface Condition? (G/P)	Good
			No	Curb Slope (%)	18.5

**Remove & Replace Curb Ramp With Two New Directional Ramps or Equivalent.**
