Access Compliance Report

Public Rights-of-Way

(Curb Ramps)

Intersection ID: N/A	Main Street: WAVERLY_WALK_AV	Cross Street: GOLF_LINKS_DR	Location: SE
ADA ID: AE88D9ACB609	Ramp Type: Perp	Initial Pass/Fail: Fail	Overall Compliance: No
		Severity Score: 12.5

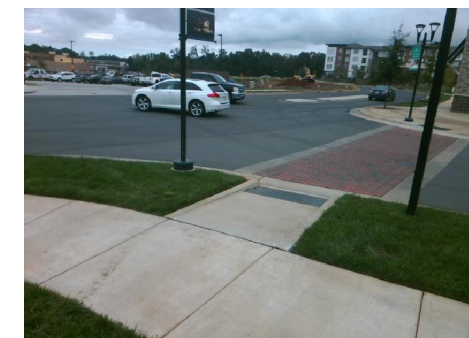
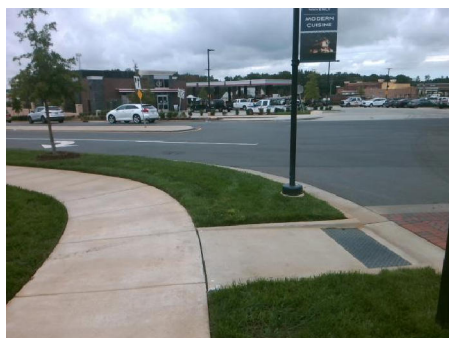
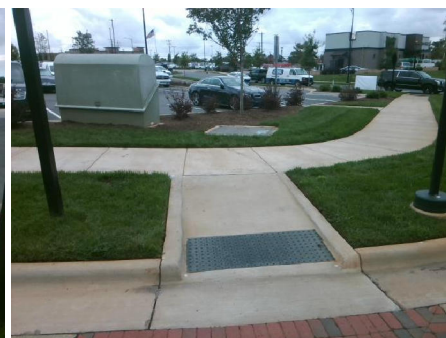
Not Found, R304.2.2

Compliance	Description	Data	Compliance	Description	Data
N/A	Ramp Length (in)	98.0	No	Ramp Slope (%)	8.6
Yes	Ramp Width (in)	59.0	Yes	Ramp XSlope (%)	1.7
N/A	Flare Type LT	N/A	N/A	Flare Type RT	N/A
N/A	Flare Slope LT (%)	N/A	N/A	Flare Slope RT (%)	N/A
N/A	Flare Traversable LT?	N/A	N/A	Flare Traversable RT?	N/A
N/A	Landing Length (in)	N/A	N/A	DWS Provided?	N/A
N/A	Landing Width (in)	N/A	N/A	DWS Contrast?	N/A
N/A	Landing Slope (%)	N/A	N/A	DWS Length (in)	N/A
N/A	Landing X Slope (%)	N/A	N/A	DWS Full Width?	N/A
N/A	Landing Curb? (Y/N)	N/A	N/A	DWS Offset (in)	N/A
N/A	Shared Landing?	N/A			
N/A	Gutter Ponding?	N/A	N/A	Gutter Slope (%)	N/A
N/A	Gutter Lip Ht (in)	N/A	N/A	Gutter X Slope (%)	N/A
N/A	Painted X Walk1?	No	N/A	Painted X Walk2?	N/A
	X Walk 1 Direction	To NE		X Walk 2 Direction	N/A
N/A	X Walk 1 Width (in)	N/A	N/A	X Walk 2 Width (in)	N/A
	X Walk 1 Slope (%)	1.6		X Walk 2 Slope (%)	N/A
	X Walk 1 X Slope (%)	2.5		X Walk 2 X Slope (%)	N/A

Remove & Replace Entire Ramp.
