Access Compliance Report

Public Rights-of-Way

(Curb Ramps)

Intersection ID: 48138	Main Street: BEATY_CALDWELL_LN	Cross Street: MCCAMEY_DR	Location: SW
ADA ID: AE8E5780A581	Ramp Type: PerpDiag	Initial Pass/Fail: Fail	Overall Compliance: No
Severity Score: 8.75			
Codes/Mitigation Info/Possible Solution		Field Measurements/Component Compliance

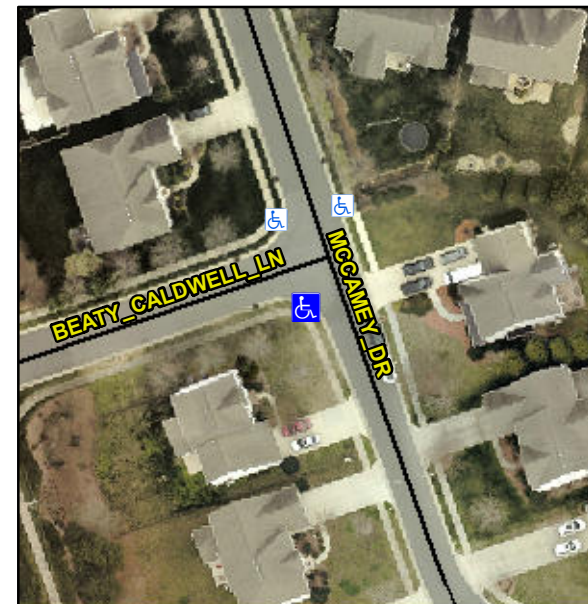
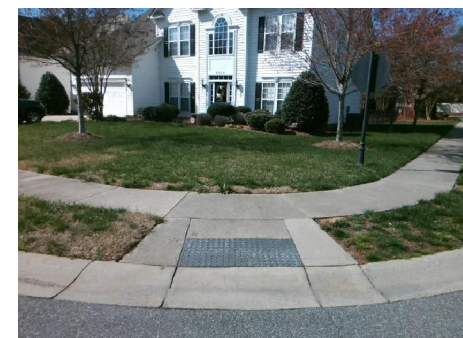
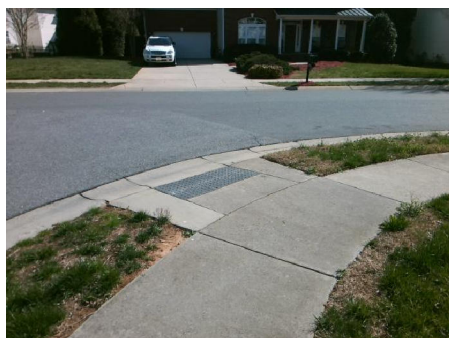
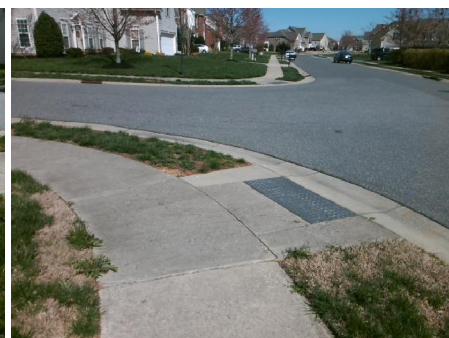
Not Found, R304.5.1

Compliance	Description	Data	Compliance	Description	Data
N/A	Ramp Length (in)	48.0	Yes	Ramp Slope (%)	7.6
No	Ramp Width (in)	47.0	Yes	Ramp XSlope (%)	2.0
N/A	Flare Type LT	N/A	N/A	Flare Type RT	N/A
N/A	Flare Slope LT (%)	N/A	N/A	Flare Slope RT (%)	N/A
N/A	Flare Traversable LT?	N/A	N/A	Flare Traversable RT?	N/A
N/A	Landing Length (in)	N/A	N/A	DWS Provided?	N/A
N/A	Landing Width (in)	N/A	N/A	DWS Contrast?	N/A
N/A	Landing Slope (%)	N/A	N/A	DWS Length (in)	N/A
N/A	Landing X Slope (%)	N/A	N/A	DWS Full Width?	N/A
N/A	Landing Curb? (Y/N)	N/A	N/A	DWS Offset (in)	N/A
N/A	Shared Landing?	N/A			
N/A	Gutter Ponding?	N/A	N/A	Gutter Slope (%)	N/A
N/A	Gutter Lip Ht (in)	N/A	N/A	Gutter X Slope (%)	N/A
N/A	Painted X Walk1?	No	N/A	Painted X Walk2?	No
	X Walk 1 Direction	To E		X Walk 2 Direction	To N
N/A	X Walk 1 Width (in)	N/A	N/A	X Walk 2 Width (in)	N/A
	X Walk 1 Slope (%)	1.7		X Walk 2 Slope (%)	2.2
	X Walk 1 X Slope (%)	1.4		X Walk 2 X Slope (%)	1.5

N/A	Ramp inside XWalk1?	N/A	N/A	Ramp inside XWalk2?	N/A
	Road Slope (%)	1.0	N/A	Clear Space?	N/A
	Road X Slope (%)	1.3	N/A	Clear Space to XWalk (in)	N/A
N/A	Any Obstructions?	N/A	N/A	Storm Grate/Utility Hazard?	N/A
	Obstruction Type			Storm Grate/Utility Type	
		N/A			N/A
			Yes	Surface Condition? (G/P)	Good

Remove & Replace Curb Ramp With Two New Directional Ramps or Equivalent.

Total Cost: \$ 3200.00
