Access Compliance Report

Public Rights-of-Way

(Curb Ramps)

Intersection ID: 52583	Main Street: NEW_RENAISSANCE_WY	Cross Street: N/A	Location: SE
ADA ID: AE8FF401397C	Ramp Type: MedianPerp	Initial Pass/Fail: Fail	Overall Compliance: No
Codes/Mitigation Info/Possible Solution		Field Measurements/Component Compliance	
Severity Score: 12.5

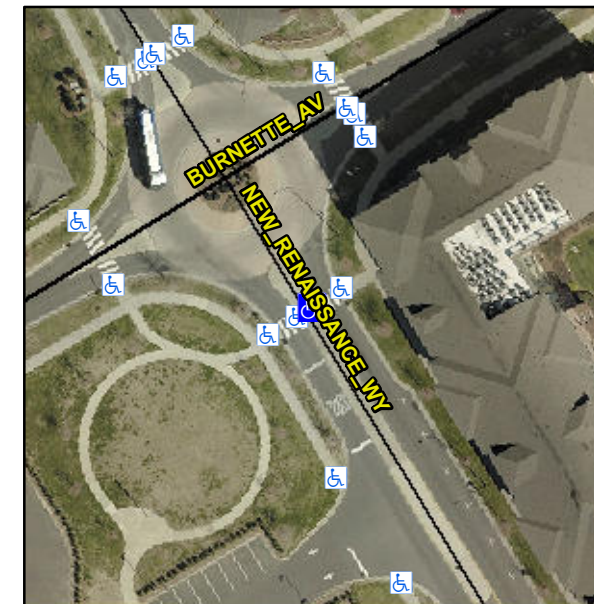
Compliance	Description	Data	Compliance	Description	Data
N/A	Ramp Length (in)	25.0	No	Ramp Slope (%)	8.8
Yes	Ramp Width (in)	72.0	Yes	Ramp XSlope (%)	1.2
N/A	Flare Type LT	N/A	N/A	Flare Type RT	N/A
N/A	Flare Slope LT (%)	N/A	N/A	Flare Slope RT (%)	N/A
N/A	Flare Traversable LT?	N/A	N/A	Flare Traversable RT?	N/A
N/A	Landing Length (in)	N/A	N/A	DWS Provided?	N/A
N/A	Landing Width (in)	N/A	N/A	DWS Contrast?	N/A
N/A	Landing Slope (%)	N/A	N/A	DWS Length (in)	N/A
N/A	Landing X Slope (%)	N/A	N/A	DWS Full Width?	N/A
N/A	Landing Curb? (Y/N)	N/A	N/A	DWS Offset (in)	N/A
N/A	Shared Landing?	N/A			
N/A	Gutter Ponding?	N/A	N/A	Gutter Slope (%)	N/A
N/A	Gutter Lip Ht (in)	N/A	N/A	Gutter X Slope (%)	N/A
N/A	Painted X Walk1?	Yes	N/A	Painted X Walk2?	N/A
	X Walk 1 Direction	To NE		X Walk 2 Direction	N/A
N/A	X Walk 1 Width (in)	119.0	N/A	X Walk 2 Width (in)	N/A
	X Walk 1 Slope (%)	2.6		X Walk 2 Slope (%)	N/A
	X Walk 1 X Slope (%)	2.3		X Walk 2 X Slope (%)	N/A

N/A	Ramp inside XWalk1?	Yes	N/A	Ramp inside XWalk2?	N/A
	Road Slope (%)	N/A	N/A	Clear Space?	N/A
	Road X Slope (%)	N/A	N/A	Clear Space to XWalk (in)	N/A
N/A	Any Obstructions?	N/A	N/A	Storm Grate/Utility Hazard?	N/A
	Obstruction Type			Storm Grate/Utility Type	
		N/A			N/A
			Yes	Surface Condition? (G/P)	Good

Possible Solutions:

Remove & Replace Entire Ramp.

R304.2.2

Total Cost: \$ 1650.00
