Access Compliance Report Public Rights-of-Way (Curb Ramps)

Intersection ID: 49701 Main Street: SCOTTSMAN TRACE DR **Cross Street: HIGHLAND MEADOW RD** Location: SE ADA ID: AE98C808A2BA Ramp Type: PerpDiag Initial Pass/Fail: Fail **Overall Compliance: No Severity Score:** 37.5

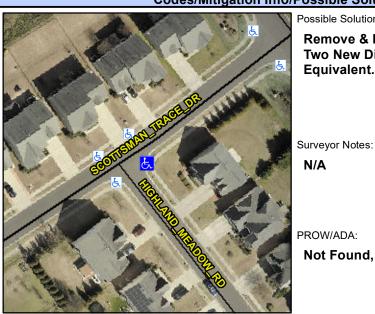
Not Found, R304.2.2, R304.5.3

Compliance Description		Data	Compliance		Description	Data
N/A	Ramp Length (in)	48.0	No	Ramp	Slope (%)	8.8
Yes	Ramp Width (in)	48.0	No	Ramp	XSlope (%)	9.2
N/A	Flare Type LT	N/A	N/A	Flare	Type RT	N/A
N/A	Flare Slope LT (%)	N/A	N/A	Flare	Slope RT (%)	N/A
N/A	Flare Traversable LT?	N/A	N/A	Flare	Traversable RT?	N/A
N/A	Landing Length (in)	N/A	N/A	DWS	Provided?	N/A
N/A	Landing Width (in)	N/A	N/A	DWS	Contrast?	N/A
N/A	Landing Slope (%)	N/A	N/A	DWS	Length (in)	N/A
N/A	Landing X Slope (%)	N/A	N/A	DWS	Full Width?	N/A
N/A	Landing Curb? (Y/N)	N/A	N/A	DWS	Offset (in)	N/A
N/A	Shared Landing?	N/A				
N/A	Gutter Ponding?	N/A	N/A	Gutte	r Slope (%)	N/A
N/A	Gutter Lip Ht (in)	N/A	N/A	Gutte	r X Slope (%)	N/A
N/A	Painted X Walk1?	No	N/A	Paint	ed X Walk2?	No
	X Walk 1 Direction	To NW		X Wa	lk 2 Direction	To SW
N/A	X Walk 1 Width (in)	N/A	N/A	X Wa	lk 2 Width (in)	N/A
	X Walk 1 Slope (%)	8.4		X Wa	lk 2 Slope (%)	0.5
	X Walk 1 X Slope (%)	2.2		X Wa	lk 2 X Slope (%)	4.2

N/A	Ramp inside XWalk1?	N/A	N/A	Ram	inside XWalk2?	N/A
	Road Slope (%)	5.0	N/A	Clear	Space?	N/A
	Road X Slope (%)	3.3	N/A	Clear	Space to XWalk (in)	N/A
N/A	Any Obstructions?	N/A	N/A	Storn	n Grate/Utility Hazard?	N/A
	Obstruction Type		l	Storn	n Grate/Utility Type	
		N/A	l			N/A

SCOTTSMAN TRACE DR None **HIGHLAND MEADOW RD** StopSign Possible Solutions: Remove & Replace Curb Ramp With **Two New Directional Ramps or** Equivalent.
