Access Compliance Report

Public Rights-of-Way

(Curb Ramps)

Intersection ID: 48438	Main Street: BARRANDS_LN	Cross Street: LATHERTON_LN	Location: NW
ADA ID: AE990C57F128	Ramp Type: BlendTrans1	Initial Pass/Fail: Fail	Overall Compliance: No
		Severity Score: 8.75

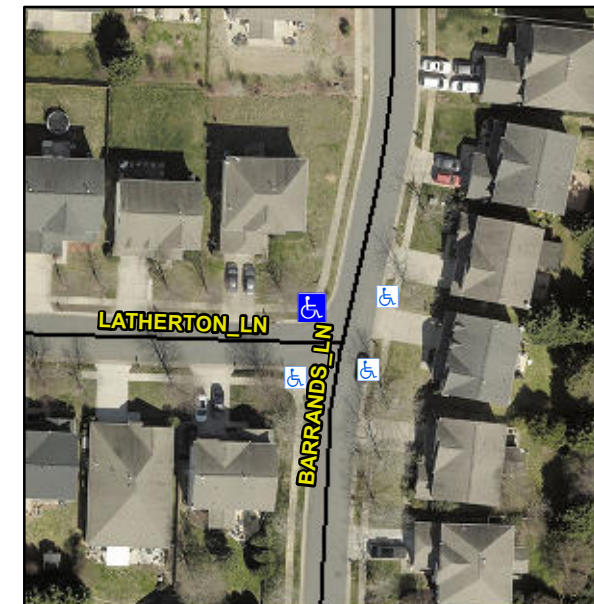
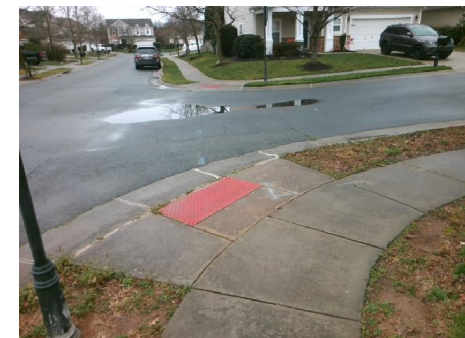
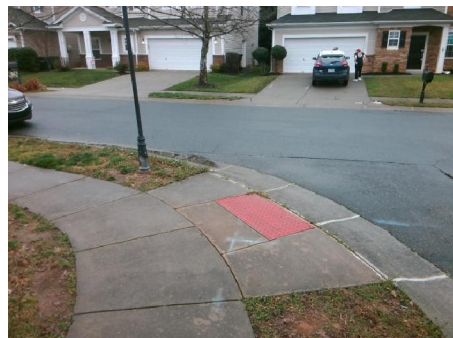
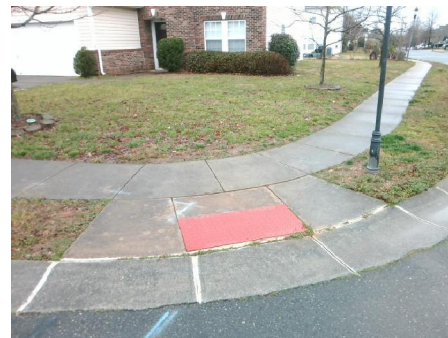
Compliance	Description	Data	Compliance	Description	Data
N/A	Ramp Length (in)	48.0	Yes	BlendTrans Slope (%)	2.1
No	Ramp Width (in)	44.0	Yes	BlendTrans XSlope (%)	1.4
N/A	Flare Type LT	N/A	N/A	Flare Type RT	N/A
N/A	Flare Slope LT (%)	N/A	N/A	Flare Slope RT (%)	N/A
N/A	Flare Traversable LT?	N/A	N/A	Flare Traversable RT?	N/A
N/A	Landing Length (in)	N/A	N/A	DWS Provided?	N/A
N/A	Landing Width (in)	N/A	N/A	DWS Contrast?	N/A
N/A	Landing Slope (%)	N/A	N/A	DWS Length (in)	N/A
N/A	Landing X Slope (%)	N/A	N/A	DWS Full Width?	N/A
N/A	Landing Curb? (Y/N)	N/A	N/A	DWS Offset (in)	N/A
N/A	Shared Landing?	N/A			
N/A	Gutter Ponding?	N/A	N/A	Gutter Slope (%)	N/A
N/A	Gutter Lip Ht (in)	N/A	N/A	Gutter X Slope (%)	N/A
N/A	Painted X Walk1?	No	N/A	Painted X Walk2?	No
	X Walk 1 Direction	To S		X Walk 2 Direction	To E
	X Walk 1 Width (in)	N/A		X Walk 2 Width (in)	N/A
	X Walk 1 Slope (%)	2.1		X Walk 2 Slope (%)	2.4
	X Walk 1 X Slope (%)	0.2		X Walk 2 X Slope (%)	0.6

N/A	Ramp inside XWalk1?	N/A	N/A	Ramp inside XWalk2?	N/A
	Road Slope (%)	0.7		Clear Space?	N/A
	Road X Slope (%)	0.5	N/A	Clear Space to XWalk (in)	N/A
N/A	Any Obstructions?	N/A	N/A	Storm Grate/Utility Hazard?	N/A
	Obstruction Type			Storm Grate/Utility Type	
		N/A			N/A
			Yes	Surface Condition? (G/P)	Good
			N/A	Curb Slope (%)	3.3

Remove & Replace Curb Ramp With Two New Directional Ramps or Equivalent.
