## **Access Compliance Report Public Rights-of-Way** (Curb Ramps)

Intersection ID: 21002 Main Street: HANSON\_RD **Cross Street: MICROSOFT WY** Location: W ADA ID: AEAC25292BB3 Ramp Type: Directional1 Initial Pass/Fail: Fail **Overall Compliance: No Severity Score:** 37.5

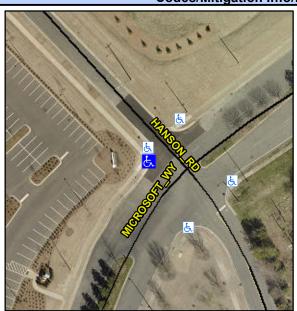
Comp	liance Description	Data	Comp	liance	Description	Data
N/A	Ramp Length (in)	48.0	N/A	Grad	e Break?	N/A
Yes	Ramp Width (in)	50.0	N/A	Grad	Grade Break Slope (%)	
No	Ramp Slope (%)	10.7	N/A	Grad	Grade Break XSlope (%)	
No	Ramp XSlope (%)	7.5				
N/A	Flare Type LT	N/A	N/A	Flare	Type RT	N/A
N/A	Flare Slope LT (%)	N/A	N/A	Flare	Slope RT (%)	0.0
N/A	Flare Traversable LT?	N/A	N/A	Flare	Traversable RT?	N/A
N/A	Landing Length (in)	0.0	N/A	DWS	Provided?	N/A
N/A	Landing Width (in)	0.0	N/A	DWS	Contrast?	N/A
N/A	Landing Slope (%)	0.0	N/A	DWS	Length (in)	N/A
N/A	Landing X Slope (%)	0.0	N/A	DWS	Full Width?	N/A
N/A	Landing Curb? (Y/N)	N/A	N/A	DWS	Offset LT (in)	N/A
N/A	Shared Landing?	N/A	N/A	DWS	Offset RT (in)	N/A
N/A	Gutter Ponding?	0.0	N/A	Gutte	r Slope (%)	N/A
N/A	Gutter Lip Ht (in)	0.0	N/A	Gutte	r X Slope (%)	N/A
N/A	Painted X Walk1?	No		Road	Slope (%)	1.3
	X Walk 1 Direction	To SE		Road	X Slope (%)	0.4
	X Walk 1 Width (in)	N/A		Clear	Space?	N/A

X Walk 1 Slope (%)	1.3	N/A	Clear	Space to XWalk (in)	N/A
	X Walk 1 X Slope (%)	0.4	N/A	Storn	n Grate/Utility Hazard?	N/A
N/A	Ramp inside XWalk1?	N/A		Storn	n Grate/Utility Type	
N/A	Any Obstructions?	N/A				N/A
	Obstruction Type		Yes	Surfa	ce Condition? (G/P)	Good
		N/A	N/A	Curb	Slope (%)	2.4

Possible Solution		Field Me	
Possible Solutions:	Comp	iance Description	
Remove & Replace Entire Ramp.	N/A	Ramp Length (in)	
·	Yes	Ramp Width (in)	
	No	Ramp Slope (%)	
	No	Ramp XSlope (%)	
	N/A	Flare Type LT	
	N/A	Flare Slope LT (%)	
Surveyor Notes:	N/A	Flare Traversable LT	
AERIAL OUTDATED	N/A	Landing Length (in)	
	N/A	Landing Width (in)	
	N/A	Landing Slope (%)	
	N/A	Landing X Slope (%	
PROW/ADA:	N/A	Landing Curb? (Y/N	
R304.2.2, R304.5.3	N/A	Shared Landing?	
	N/A	Gutter Ponding?	
	N/A	Gutter Lip Ht (in)	
	N/A	Painted X Walk1?	
		X Walk 1 Direction	
		X Walk 1 Width (in)	
		X Walk 1 Slope (%)

1600.00
