Access Compliance Report

Public Rights-of-Way

(Curb Ramps)

Intersection ID: 31697	Main Street: ATLAS_CEDAR_DR	Cross Street: ROBINSON_CHURCH_RD	Location: SW
ADA ID: AEAC598E3603	Ramp Type: Perp	Initial Pass/Fail: Fail	Overall Compliance: No
Severity Score: 21.25			
Codes/Mitigation Info/Possible Solution		Field Measurements/Component Compliance

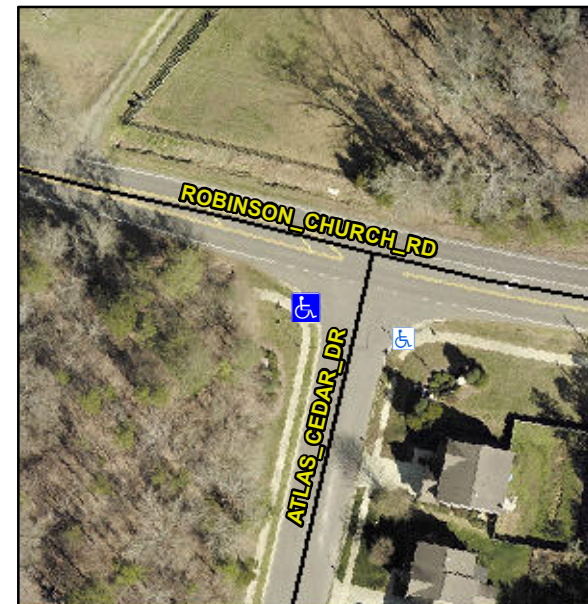
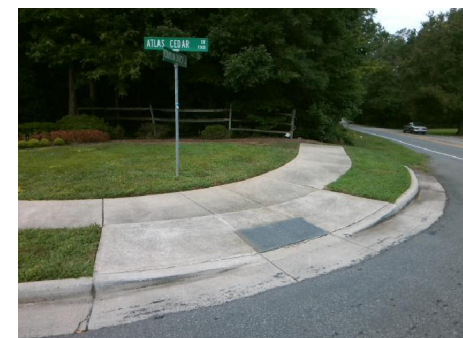
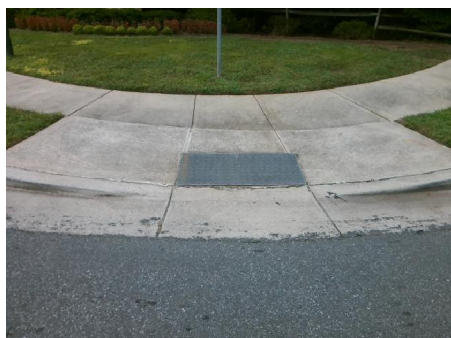
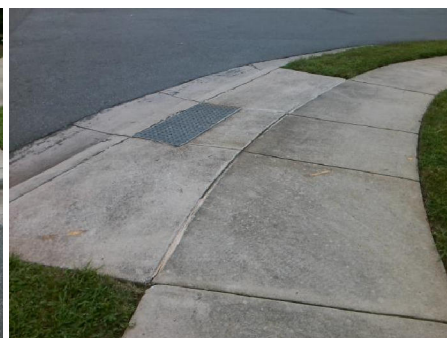
Compliance	Description	Data	Compliance	Description	Data
N/A	Ramp Length (in)	48.0	No	Ramp Slope (%)	8.6
No	Ramp Width (in)	40.0	Yes	Ramp XSlope (%)	1.8
N/A	Flare Type LT	N/A	N/A	Flare Type RT	N/A
N/A	Flare Slope LT (%)	N/A	N/A	Flare Slope RT (%)	N/A
N/A	Flare Traversable LT?	N/A	N/A	Flare Traversable RT?	N/A
N/A	Landing Length (in)	N/A	N/A	DWS Provided?	N/A
N/A	Landing Width (in)	N/A	N/A	DWS Contrast?	N/A
N/A	Landing Slope (%)	N/A	N/A	DWS Length (in)	N/A
N/A	Landing X Slope (%)	N/A	N/A	DWS Full Width?	N/A
N/A	Landing Curb? (Y/N)	N/A	N/A	DWS Offset (in)	N/A
N/A	Shared Landing?	N/A			
N/A	Gutter Ponding?	N/A	N/A	Gutter Slope (%)	N/A
N/A	Gutter Lip Ht (in)	N/A	N/A	Gutter X Slope (%)	N/A
N/A	Painted X Walk1?	No	N/A	Painted X Walk2?	N/A
	X Walk 1 Direction	To SE		X Walk 2 Direction	N/A
N/A	X Walk 1 Width (in)	N/A	N/A	X Walk 2 Width (in)	N/A
	X Walk 1 Slope (%)	9.6		X Walk 2 Slope (%)	N/A
	X Walk 1 X Slope (%)	9.1		X Walk 2 X Slope (%)	N/A

N/A	Ramp inside XWalk1?	N/A	N/A	Ramp inside XWalk2?	N/A
	Road Slope (%)	N/A	N/A	Clear Space?	N/A
	Road X Slope (%)	N/A	N/A	Clear Space to XWalk (in)	N/A
N/A	Any Obstructions?	N/A	N/A	Storm Grate/Utility Hazard?	N/A
	Obstruction Type			Storm Grate/Utility Type	
		N/A			N/A
			Yes	Surface Condition? (G/P)	Good

Possible Solutions:

Remove & Replace Entire Ramp.

R304.5.1, R304.2.2
