Access Compliance Report

Public Rights-of-Way

(Curb Ramps)

Intersection ID: 18844	Main Street: NATIONS_FORD_RD	Cross Street: TYVOLA_RD	Location: NE
ADA ID: AEB524E9A574	Ramp Type: BlendTrans1	Initial Pass/Fail: Fail	Overall Compliance: No
			Severity Score: 18.75

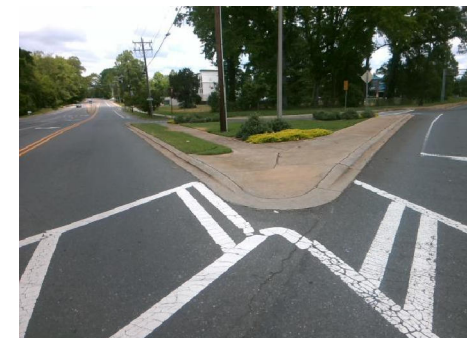
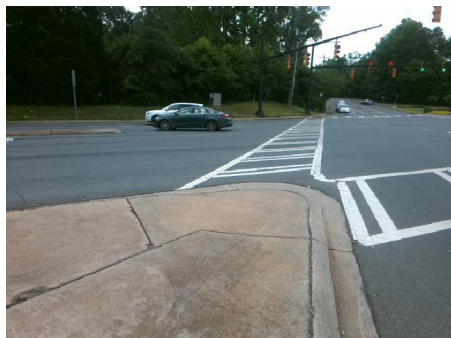
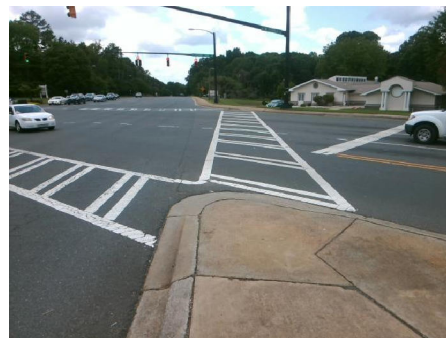
LOCATED ON ISLAND

Compliance	Description	Data	Compliance	Description	Data
N/A	Ramp Length (in)	48.0	Yes	BlendTrans Slope (%)	3.3
No	Ramp Width (in)	32.0	No	BlendTrans XSlope (%)	3.1
N/A	Flare Type LT	N/A	N/A	Flare Type RT	N/A
N/A	Flare Slope LT (%)	N/A	N/A	Flare Slope RT (%)	N/A
N/A	Flare Traversable LT?	N/A	N/A	Flare Traversable RT?	N/A
N/A	Landing Length (in)	N/A	N/A	DWS Provided?	N/A
N/A	Landing Width (in)	N/A	N/A	DWS Contrast?	N/A
N/A	Landing Slope (%)	N/A	N/A	DWS Length (in)	N/A
N/A	Landing X Slope (%)	N/A	N/A	DWS Full Width?	N/A
N/A	Landing Curb? (Y/N)	N/A	N/A	DWS Offset (in)	N/A
N/A	Shared Landing?	N/A			
N/A	Gutter Ponding?	N/A	N/A	Gutter Slope (%)	N/A
N/A	Gutter Lip Ht (in)	N/A	N/A	Gutter X Slope (%)	N/A
N/A	Painted X Walk1?	Yes	N/A	Painted X Walk2?	Yes
	X Walk 1 Direction	To W		X Walk 2 Direction	To SW
	X Walk 1 Width (in)	88.0		X Walk 2 Width (in)	78.0
	X Walk 1 Slope (%)	0.3		X Walk 2 Slope (%)	4.0
	X Walk 1 X Slope (%)	1.5		X Walk 2 X Slope (%)	0.9

N/A	Ramp inside XWalk1?	Yes	N/A	Ramp inside XWalk2?	Yes
	Road Slope (%)	0.5		Clear Space?	N/A
	Road X Slope (%)	1.8	N/A	Clear Space to XWalk (in)	N/A
N/A	Any Obstructions?	N/A	N/A	Storm Grate/Utility Hazard?	N/A
	Obstruction Type			Storm Grate/Utility Type	
		N/A			N/A
		Yes		Surface Condition? (G/P)	Good
		N/A		Curb Slope (%)	4.3

Remove & Replace Curb Ramp With Two New Directional Ramps or Equivalent.
