# Access Compliance Report

## Public Rights-of-Way

### (Curb Ramps)

Intersection ID: 19435	Main Street: MANNING_DR	Cross Street: WINTERCREST_LN	Location: W
ADA ID: AEBAC288BD82	Ramp Type: Perp	Initial Pass/Fail: Fail	Overall Compliance: No
Severity Score: 8.75			
Codes/Mitigation Info/Possible Solution		Field Measurements/Component Compliance

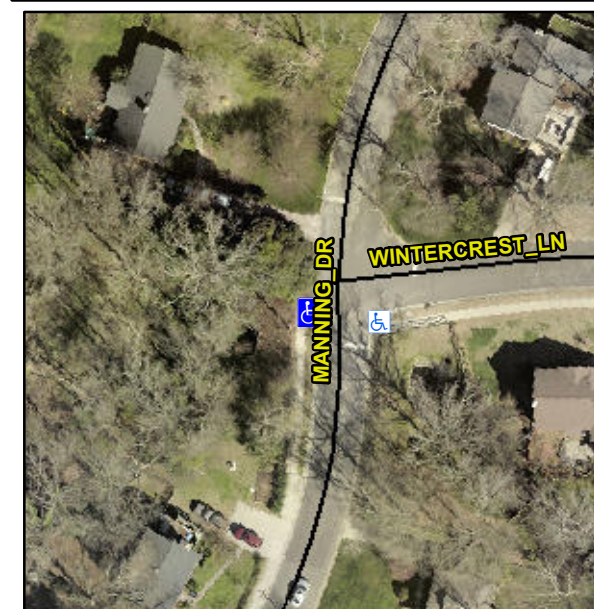
**Not Found, R304.5.1**

Compliance	Description	Data	Compliance	Description	Data
N/A	Ramp Length (in)	48.0	Yes	Ramp Slope (%)	5.9
No	Ramp Width (in)	47.0	Yes	Ramp XSlope (%)	1.7
N/A	Flare Type LT	N/A	N/A	Flare Type RT	N/A
N/A	Flare Slope LT (%)	N/A	N/A	Flare Slope RT (%)	N/A
N/A	Flare Traversable LT?	N/A	N/A	Flare Traversable RT?	N/A
N/A	Landing Length (in)	N/A	N/A	DWS Provided?	N/A
N/A	Landing Width (in)	N/A	N/A	DWS Contrast?	N/A
N/A	Landing Slope (%)	N/A	N/A	DWS Length (in)	N/A
N/A	Landing X Slope (%)	N/A	N/A	DWS Full Width?	N/A
N/A	Landing Curb? (Y/N)	N/A	N/A	DWS Offset (in)	N/A
N/A	Shared Landing?	N/A			
N/A	Gutter Ponding?	Yes	N/A	Gutter Slope (%)	N/A
N/A	Gutter Lip Ht (in)	N/A	N/A	Gutter X Slope (%)	N/A
N/A	Painted X Walk1?	No	N/A	Painted X Walk2?	N/A
	X Walk 1 Direction	To E		X Walk 2 Direction	N/A
N/A	X Walk 1 Width (in)	N/A	N/A	X Walk 2 Width (in)	N/A
	X Walk 1 Slope (%)	7.4		X Walk 2 Slope (%)	N/A
	X Walk 1 X Slope (%)	3.2		X Walk 2 X Slope (%)	N/A

N/A	Ramp inside XWalk1?	N/A	N/A	Ramp inside XWalk2?	N/A
	Road Slope (%)	N/A	N/A	Clear Space?	N/A
	Road X Slope (%)	N/A	N/A	Clear Space to XWalk (in)	N/A
N/A	Any Obstructions?	N/A	N/A	Storm Grate/Utility Hazard?	N/A
	Obstruction Type			Storm Grate/Utility Type	
		N/A			N/A
			Yes	Surface Condition? (G/P)	Good

**Remove & Replace Entire Ramp.**
