# Access Compliance Report Public Rights-of-Way (Curb Ramps)

Intersection ID: 10038935	Main Street: STONECROFT_PARK_DR	Cross Street: N/A	Location: SE
ADA ID: AEBD3B9A4889	Ramp Type: Perp	Initial Pass/Fail: Fail	Overall Compliance: No Severity Score: 13.75

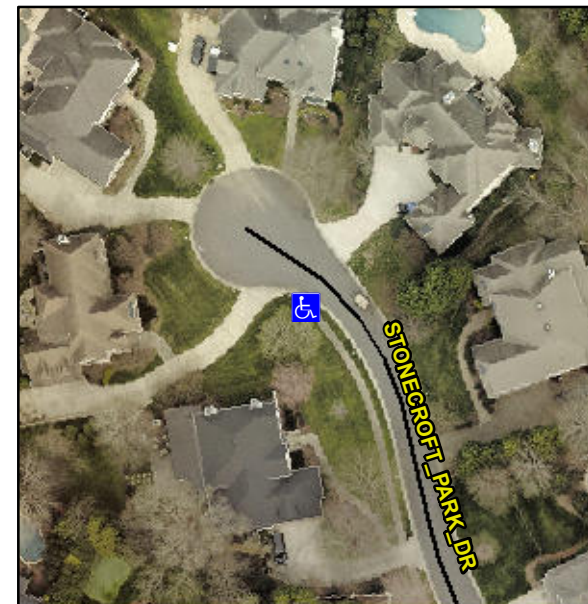
Compliance	Description	Data	Compliance	Description	Data
N/A	Ramp Length (in)	42.0	No	Ramp Slope (%)	9.5
Yes	Ramp Width (in)	48.0	Yes	Ramp XSlope (%)	2.6
N/A	Flare Type LT	N/A	N/A	Flare Type RT	N/A
N/A	Flare Slope LT (%)	N/A	N/A	Flare Slope RT (%)	N/A
N/A	Flare Traversable LT?	N/A	N/A	Flare Traversable RT?	N/A
N/A	Landing Length (in)	N/A	N/A	DWS Provided?	N/A
N/A	Landing Width (in)	N/A	N/A	DWS Contrast?	N/A
N/A	Landing Slope (%)	N/A	N/A	DWS Length (in)	N/A
N/A	Landing X Slope (%)	N/A	N/A	DWS Full Width?	N/A
N/A	Landing Curb? (Y/N)	N/A	N/A	DWS Offset (in)	N/A
N/A	Shared Landing?	N/A			
N/A	Gutter Ponding?	N/A	N/A	Gutter Slope (%)	N/A
N/A	Gutter Lip Ht (in)	N/A	N/A	Gutter X Slope (%)	N/A
N/A	Painted X Walk1?	No	N/A	Painted X Walk2?	N/A
	X Walk 1 Direction	To NE		X Walk 2 Direction	N/A
N/A	X Walk 1 Width (in)	N/A	N/A	X Walk 2 Width (in)	N/A
	X Walk 1 Slope (%)	4.7		X Walk 2 Slope (%)	N/A
	X Walk 1 X Slope (%)	5.2		X Walk 2 X Slope (%)	N/A

N/A	Ramp inside XWalk1?	N/A	N/A	Ramp inside XWalk2?	N/A
	Road Slope (%)	N/A	N/A	Clear Space?	N/A
	Road X Slope (%)	N/A	N/A	Clear Space to XWalk (in)	N/A
N/A	Any Obstructions?	N/A	N/A	Storm Grate/Utility Hazard?	N/A
	Obstruction Type			Storm Grate/Utility Type	
		N/A			N/A
			Yes	Surface Condition? (G/P)	Good

**Remove & Replace Entire Ramp.**

**R304.2.2**
