# Access Compliance Report

## Public Rights-of-Way

### (Curb Ramps)

Intersection ID: 16497	Main Street: HAMPTON_AV	Cross Street: PORTLAND_AV	Location: NW
ADA ID: AEBE19871E97	Ramp Type: PerpDiag	Initial Pass/Fail: Fail	Overall Compliance: No
Severity Score: 22.5			
Codes/Mitigation Info/Possible Solution		Field Measurements/Component Compliance

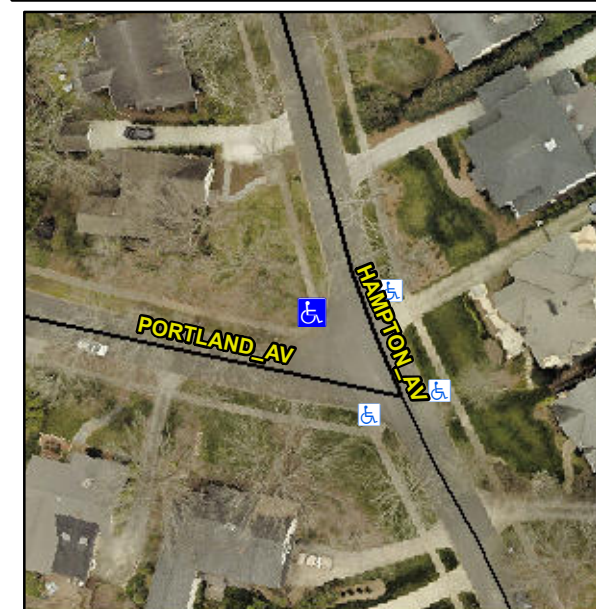
PROW/ADA:

**Not Found, R304.5.1, R304.2.2, R304.5.3**

Compliance	Description	Data	Compliance	Description	Data
N/A	Ramp Length (in)	54.0	No	Ramp Slope (%)	11.4
No	Ramp Width (in)	46.0	No	Ramp XSlope (%)	3.8
N/A	Flare Type LT	N/A	N/A	Flare Type RT	N/A
N/A	Flare Slope LT (%)	N/A	N/A	Flare Slope RT (%)	N/A
N/A	Flare Traversable LT?	N/A	N/A	Flare Traversable RT?	N/A
N/A	Landing Length (in)	N/A	N/A	DWS Provided?	N/A
N/A	Landing Width (in)	N/A	N/A	DWS Contrast?	N/A
N/A	Landing Slope (%)	N/A	N/A	DWS Length (in)	N/A
N/A	Landing X Slope (%)	N/A	N/A	DWS Full Width?	N/A
N/A	Landing Curb? (Y/N)	N/A	N/A	DWS Offset (in)	N/A
N/A	Shared Landing?	N/A			
N/A	Gutter Ponding?	N/A	N/A	Gutter Slope (%)	N/A
N/A	Gutter Lip Ht (in)	1.0	N/A	Gutter X Slope (%)	N/A
N/A	Painted X Walk1?	No	N/A	Painted X Walk2?	No
	X Walk 1 Direction	To SE		X Walk 2 Direction	To E
N/A	X Walk 1 Width (in)	N/A	N/A	X Walk 2 Width (in)	N/A
	X Walk 1 Slope (%)	3.5		X Walk 2 Slope (%)	3.8
	X Walk 1 X Slope (%)	2.8		X Walk 2 X Slope (%)	2.4

N/A	Ramp inside XWalk1?	N/A	N/A	Ramp inside XWalk2?	N/A
	Road Slope (%)	3.0	N/A	Clear Space?	N/A
	Road X Slope (%)	1.3	N/A	Clear Space to XWalk (in)	N/A
N/A	Any Obstructions?	N/A	N/A	Storm Grate/Utility Hazard?	N/A
	Obstruction Type			Storm Grate/Utility Type	
		N/A			N/A
			Yes	Surface Condition? (G/P)	Good

Possible Solutions:

**Remove & Replace Curb Ramp With Two New Directional Ramps or Equivalent.**

Total Cost: \$ 3200.00
