# Access Compliance Report

## Public Rights-of-Way

### (Curb Ramps)

Intersection ID: 2737	Main Street: SKYLINE_DR	Cross Street: VALHALLA_CT	Location: SW
ADA ID: AEC85410E947	Ramp Type: PerpDiag	Initial Pass/Fail: Fail	Overall Compliance: No
Severity Score: 33.75			
Codes/Mitigation Info/Possible Solution		Field Measurements/Component Compliance

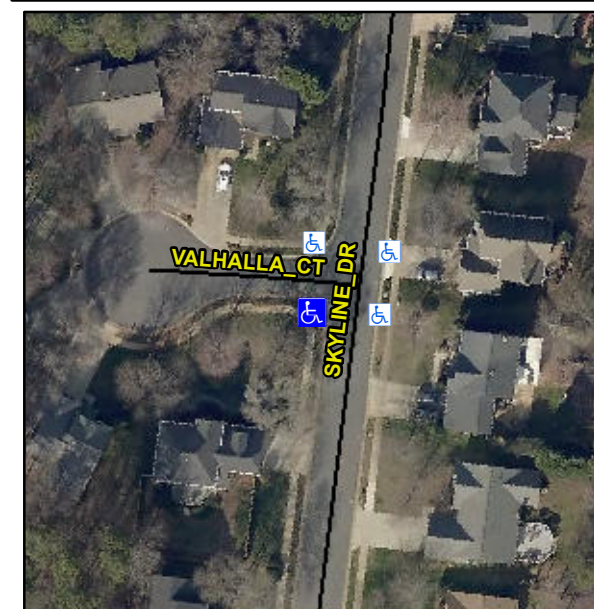
**Not Found, R304.5.1, R304.2.2, R304.5.3**

Compliance	Description	Data	Compliance	Description	Data
N/A	Ramp Length (in)	47.0	No	Ramp Slope (%)	9.3
No	Ramp Width (in)	39.0	No	Ramp XSlope (%)	5.9
N/A	Flare Type LT	N/A	N/A	Flare Type RT	N/A
N/A	Flare Slope LT (%)	N/A	N/A	Flare Slope RT (%)	N/A
N/A	Flare Traversable LT?	N/A	N/A	Flare Traversable RT?	N/A
N/A	Landing Length (in)	N/A	N/A	DWS Provided?	N/A
N/A	Landing Width (in)	N/A	N/A	DWS Contrast?	N/A
N/A	Landing Slope (%)	N/A	N/A	DWS Length (in)	N/A
N/A	Landing X Slope (%)	N/A	N/A	DWS Full Width?	N/A
N/A	Landing Curb? (Y/N)	N/A	N/A	DWS Offset (in)	N/A
N/A	Shared Landing?	N/A			
N/A	Gutter Ponding?	N/A	N/A	Gutter Slope (%)	N/A
N/A	Gutter Lip Ht (in)	N/A	N/A	Gutter X Slope (%)	N/A
N/A	Painted X Walk1?	No	N/A	Painted X Walk2?	No
	X Walk 1 Direction	To E		X Walk 2 Direction	To N
N/A	X Walk 1 Width (in)	N/A	N/A	X Walk 2 Width (in)	N/A
	X Walk 1 Slope (%)	1.1		X Walk 2 Slope (%)	9.0
	X Walk 1 X Slope (%)	10.7		X Walk 2 X Slope (%)	1.3

N/A	Ramp inside XWalk1?	N/A	N/A	Ramp inside XWalk2?	N/A
	Road Slope (%)	5.8	N/A	Clear Space?	N/A
	Road X Slope (%)	8.9	N/A	Clear Space to XWalk (in)	N/A
N/A	Any Obstructions?	N/A	N/A	Storm Grate/Utility Hazard?	N/A
	Obstruction Type			Storm Grate/Utility Type	
		N/A			N/A
			Yes	Surface Condition? (G/P)	Good

**Remove & Replace Curb Ramp With Two New Directional Ramps or Equivalent.**
