# Access Compliance Report

## Public Rights-of-Way

| Intersection ID: 19216 | Main Street: RAMA_RD | Cross Street: SARDIS_RD | Location: SE |
| ADA ID: AECD8B962E51 | Ramp Type: IslandPerp | Initial Pass/Fail: Pass | Overall Compliance: No |

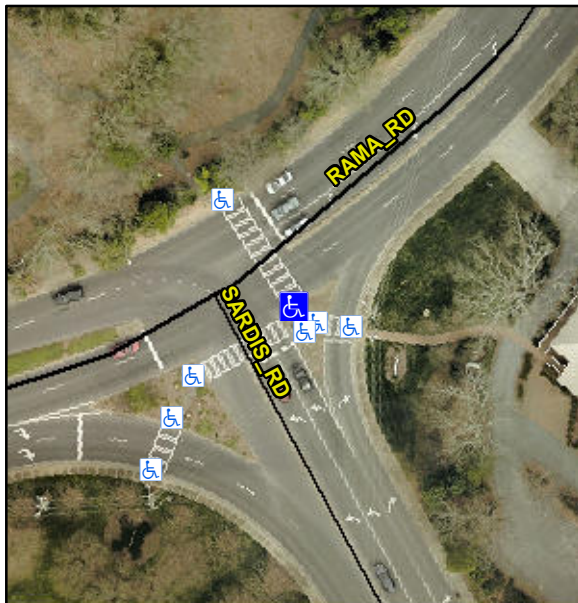
**Not Found, R304.5.3, R304.2.3,  
R305.2, R304.5.4**

| Compliance | Description | Data | Compliance | Description | Data |
|---|---|---|---|---|---|
| N/A | Ramp Length (in) | 60.0 | Yes | Ramp Slope (%) | 7.2 |
| Yes | Ramp Width (in) | 48.0 | No | Ramp XSlope (%) | 2.3 |
| N/A | Flare Slope LT (%) | 6.2 | No | Flare Slope RT (%) | 10.8 |
| N/A | Landing Curb? (Y/N) | No | No | DWS Offset (in) | 4.0 |
| Yes | Gutter Ponding? | No | No | Gutter Slope (%) | 5.6 |
| Yes | Gutter Lip Ht (in) | 0.0 | No | Gutter X Slope (%) | 2.2 |

**Remove & Replace Entire Ramp.  
Remove & Replace Gutter.**

Total Cost: \$ 4150.00
