# Access Compliance Report

## Public Rights-of-Way

### (Curb Ramps)

| Intersection ID: 46728 | Main Street: HANSBURY_DR | Cross Street: FAWN_VIEW_DR | Location: E |

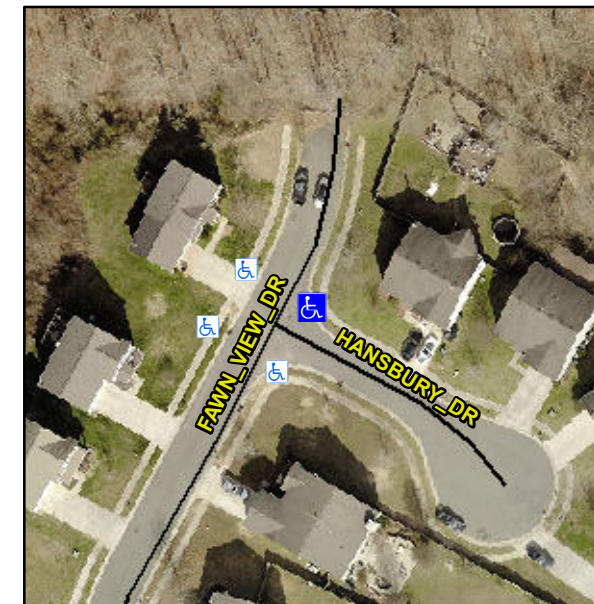
| ADA ID: AED594DCE9D2 | Ramp Type: PerpDiag | Initial Pass/Fail: Fail | Overall Compliance: No |
| Severity Score: 18.75 | | | |

| Compliance | Description | Data | Compliance | Description | Data |
|---|---|---|---|---|---|
| N/A | Ramp Length (in) | 49.0 | Yes | Ramp Slope (%) | 7.5 |
| No | Ramp Width (in) | 32.0 | No | Ramp XSlope (%) | 3.0 |

**Remove & Replace Curb Ramp With Two New Directional Ramps or Equivalent.**

**R304.5.1, R304.5.3**

Total Cost: \$ 3200.00

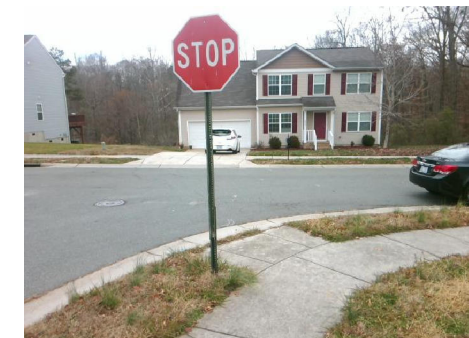
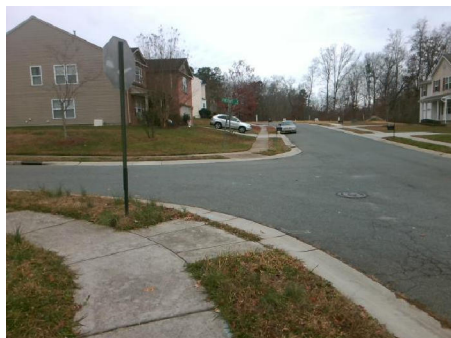
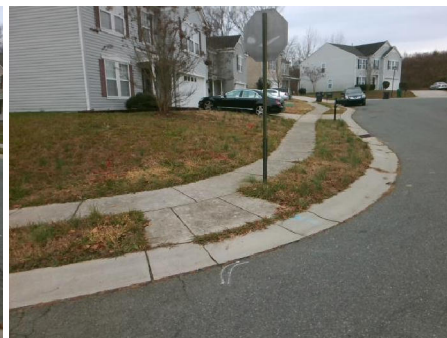
Street 1 Name **FAWN VIEW DR**  
 Stop Condition-Street 2 **None**  
 Street 2 Name **HANSBURY DR**  
 Stop Condition-Street 1 **StopSign**
