## Access Compliance Report Public Rights-of-Way (Curb Ramps)

Intersection ID: 12925 Main Street: S\_CHURCH\_ST Cross Street: W\_CARSON\_BV Location: SW

ADA ID: AED81B82C918 Ramp Type: ParaDiag Initial Pass/Fail: Fail Overall Compliance: No Severity Score: 12.5

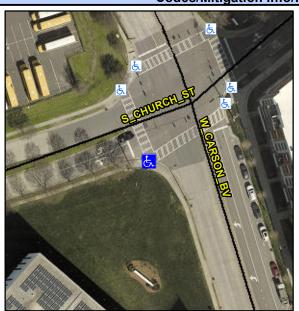
Compliance Description Da			Compliance Description		Data
N/A	Ramp Length LT (in)	65.0	N/A	Ramp Length RT (in)	N/A
Yes	s Ramp Width LT (in)	97.0	N/A	Ramp Width RT (in)	N/A
No	Ramp Slope LT (%)	11.1	N/A	Ramp Slope RT (%)	N/A
Yes	s Ramp XSlope LT (%)	1.2	N/A	Ramp XSlope RT (%)	N/A
N/A	Landing Length (in)	N/A	N/A	DWS Provided?	N/A
N/A	Landing Width (in)	N/A	N/A	DWS Contrast?	N/A
N/A	Landing Slope (%)	N/A	N/A	DWS Length (in)	N/A
N/A	Landing X Slope (%)	N/A	N/A	DWS Full Width?	N/A
N/A	Landing Curb? (Y/N)	N/A	N/A	DWS Offset (in)	N/A
N/A	A Shared Landing?	N/A			
N/A	Gutter Ponding?	N/A	N/A	Gutter Slope (%)	N/A
N/A	Gutter Lip Ht (in)	N/A	N/A	Gutter X Slope (%)	N/A
N/A	Painted X Walk1?	Yes	N/A	Painted X Walk2?	Yes
	X Walk 1 Direction	To NE		X Walk 2 Direction	To NW
N/A	X Walk 1 Width (in)	112.0	N/A	X Walk 2 Width (in)	114.0
	X Walk 1 Slope (%)	2.0		X Walk 2 Slope (%)	0.9
	X Walk 1 X Slope (%)	4.2		X Walk 2 X Slope (%)	1.2

N/A	Ramp inside XWalk1?	Yes	N/A	Ramp inside XWalk2?	Yes
	Road Slope (%)	4.8	N/A	Clear Space?	N/A
	Road X Slope (%)	0.9	N/A	Clear Space to XWalk (in)	N/A
N/A	Any Obstructions?	N/A	N/A	Storm Grate/Utility Hazard?	N/A
	Obstruction Type			Storm Grate/Utility Type	
		N/A			N/A
			Yes	Surface Condition? (G/P)	Good
			N/A	Curb Slope (%)	13.3

Remove & Replace Curb Ramp With
Two New Directional Ramps or
Equivalent.

PROW/ADA:
R304.3.2
