# Access Compliance Report

## Public Rights-of-Way

Intersection ID: 27197	Main Street: BALLANTYNE COMMONS PY	Cross Street: CRESTWOOD DR	Location: NE
ADA ID: AEE0F1206249	Ramp Type: Directional	Initial Pass/Fail: Fail	Overall Compliance: No
		Severity Score: 1.25	
Codes/Mitigation Info/Possible Solution		Field Measurements/Component Compliance

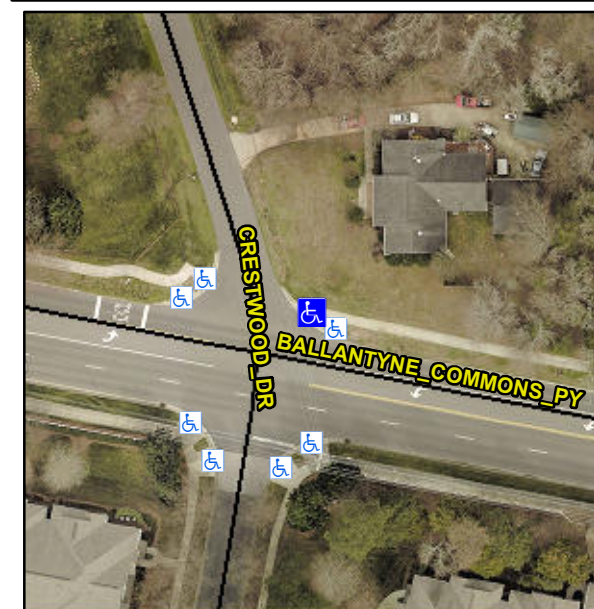
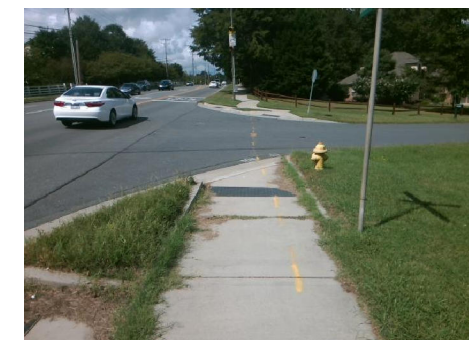
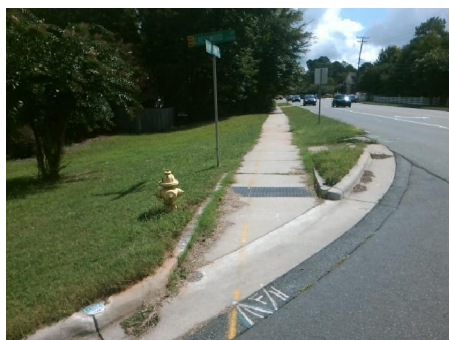
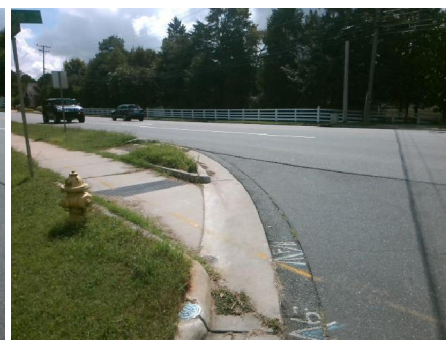
Compliance	Description	Data	Compliance	Description	Data
N/A	Ramp Length (in)	65.0	N/A	Grade Break?	N/A
Yes	Ramp Width (in)	73.0	N/A	Grade Break Slope (%)	0.0
Yes	Ramp Slope (%)	2.5	N/A	Grade Break XSlope (%)	0.0
No	Ramp XSlope (%)	4.6			
N/A	Flare Type LT	N/A	N/A	Flare Type RT	N/A
N/A	Flare Slope LT (%)	N/A	N/A	Flare Slope RT (%)	0.0
N/A	Flare Traversable LT?	N/A	N/A	Flare Traversable RT?	N/A
N/A	Landing Length (in)	0.0	N/A	DWS Provided?	N/A
N/A	Landing Width (in)	0.0	N/A	DWS Contrast?	N/A
N/A	Landing Slope (%)	0.0	N/A	DWS Length (in)	N/A
N/A	Landing X Slope (%)	0.0	N/A	DWS Full Width?	N/A
N/A	Landing Curb? (Y/N)	N/A	N/A	DWS Offset LT (in)	N/A
N/A	Shared Landing?	N/A	N/A	DWS Offset RT (in)	N/A
N/A	Gutter Ponding?	0.0	N/A	Gutter Slope (%)	N/A
N/A	Gutter Lip Ht (in)	0.0	N/A	Gutter X Slope (%)	N/A
N/A	Painted X Walk1?	No		Road Slope (%)	0.5
	X Walk 1 Direction	To W		Road X Slope (%)	11.4
	X Walk 1 Width (in)	N/A		Clear Space?	N/A

X Walk 1 Slope (%)	0.5	N/A	Clear Space to XWalk (in)	N/A
	X Walk 1 X Slope (%)	11.4	N/A	Storm Grate/Utility Hazard?	N/A
N/A	Ramp inside XWalk1?	N/A		Storm Grate/Utility Type	
N/A	Any Obstructions?	N/A			N/A
	Obstruction Type		Yes	Surface Condition? (G/P)	Good
			N/A	Curb Slope (%)	6.9

Possible Solutions:

**Remove & Replace Entire Ramp.**

PROW/ADA:

**R304.5.3**
