# Access Compliance Report

## Public Rights-of-Way (Curb Ramps)

Intersection ID: N/A	Main Street: NORTHLAKE_PLAZA_DR	Cross Street: N/A	Location: SW
ADA ID: AEE7CD067E10	Ramp Type: BlendTrans1	Initial Pass/Fail: Fail	Overall Compliance: No
		Severity Score: 8.75

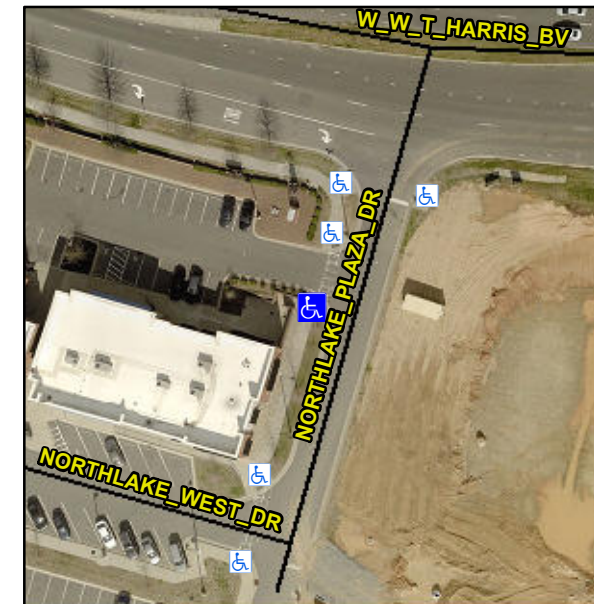
**Not Found, R304.5.1**

Compliance	Description	Data	Compliance	Description	Data
N/A	Ramp Length (in)	110.0	Yes	BlendTrans Slope (%)	2.0
No	Ramp Width (in)	44.0	Yes	BlendTrans XSlope (%)	1.1
N/A	Flare Type LT	N/A	N/A	Flare Type RT	N/A
N/A	Flare Slope LT (%)	N/A	N/A	Flare Slope RT (%)	N/A
N/A	Flare Traversable LT?	No	N/A	Flare Traversable RT?	No
N/A	Landing Length (in)	N/A	N/A	DWS Provided?	N/A
N/A	Landing Width (in)	N/A	N/A	DWS Contrast?	N/A
N/A	Landing Slope (%)	N/A	N/A	DWS Length (in)	N/A
N/A	Landing X Slope (%)	N/A	N/A	DWS Full Width?	N/A
N/A	Landing Curb? (Y/N)	N/A	N/A	DWS Offset (in)	N/A
N/A	Shared Landing?	N/A			
N/A	Gutter Ponding?	N/A	N/A	Gutter Slope (%)	N/A
N/A	Gutter Lip Ht (in)	N/A	N/A	Gutter X Slope (%)	N/A
N/A	Painted X Walk1?	No	N/A	Painted X Walk2?	Yes
	X Walk 1 Direction	To E		X Walk 2 Direction	To N
	X Walk 1 Width (in)	N/A		X Walk 2 Width (in)	56.0
	X Walk 1 Slope (%)	1.5		X Walk 2 Slope (%)	5.5
	X Walk 1 X Slope (%)	5.9		X Walk 2 X Slope (%)	0.3

N/A	Ramp inside XWalk1?	N/A	N/A	Ramp inside XWalk2?	Yes
	Road Slope (%)	2.1		Clear Space?	N/A
	Road X Slope (%)	6.7	N/A	Clear Space to XWalk (in)	N/A
N/A	Any Obstructions?	N/A	N/A	Storm Grate/Utility Hazard?	N/A
	Obstruction Type			Storm Grate/Utility Type	
		N/A			N/A
			Yes	Surface Condition? (G/P)	Good
			No	Curb Slope (%)	5.5

**Remove & Replace Curb Ramp With Two New Directional Ramps or Equivalent.**
