Access Compliance Report

Public Rights-of-Way

(Curb Ramps)

Intersection ID: 19936	Main Street: ARCHDALE_DR	Cross Street: CHERRYCREST_LN	Location: NE
ADA ID: AF07E75C4013	Ramp Type: PerpDiag	Initial Pass/Fail: Fail	Overall Compliance: No
			Severity Score: 33.75

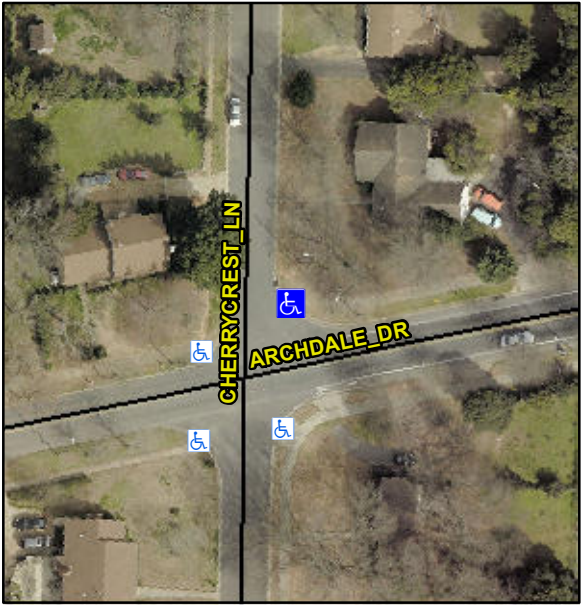
Possible Solutions:		Compliance	Description	Data
	Remove & Replace Curb Ramp With Two New Directional Ramps or Equivalent.		No	Ramp Length (in)	70.0
			No	Ramp Width (in)	46.0
			N/A	Flare Type LT	N/A
			N/A	Flare Slope LT (%)	N/A
			N/A	Flare Traversable LT?	N/A
			N/A	Landing Length (in)	N/A
			N/A	Landing Width (in)	N/A
			N/A	Landing Slope (%)	N/A
			N/A	Landing X Slope (%)	N/A
<p>Surveyor Notes:</p> <p>N/A</p> <p>PROW/ADA:</p> <p>Not Found, R304.5.1, R304.2.2, R304.5.3</p>			N/A	Flare Type RT	N/A
			N/A	Flare Slope RT (%)	N/A
			N/A	Flare Traversable RT?	N/A
			N/A	DWS Provided?	N/A
			N/A	DWS Contrast?	N/A
			N/A	DWS Length (in)	N/A
			N/A	DWS Full Width?	N/A
			N/A	DWS Offset (in)	N/A
			N/A	Gutter Ponding?	N/A
			N/A	Gutter Lip Ht (in)	N/A
<p>Total Cost:</p> <p>\$ 3200.00</p>			No	Painted X Walk1?	No
				X Walk 1 Direction	To SW

N/A	X Walk 1 Width (in)	N/A
			4.9	X Walk 1 Slope (%)	1.9
			2.0	X Walk 1 X Slope (%)	4.2
			N/A	Ramp inside XWalk1?	N/A
			4.9	Road Slope (%)	N/A
			3.8	Road X Slope (%)	N/A
			N/A	Any Obstructions?	N/A
				Obstruction Type	
			N/A	Storm Grate/Utility Hazard?	N/A
				Storm Grate/Utility Type	
			N/A		N/A
			Yes	Surface Condition? (G/P)	Good
