Access Compliance Report Public Rights-of-Way (Curb Ramps)

Intersection ID: 8379 Main Street: NEWLAND RD **Cross Street: CATHERINE SIMMONS AV** Location: NW **ADA ID: AF09BF5F5694** Ramp Type: Perp Initial Pass/Fail: Fail **Overall Compliance: No** Severity Score: 33.75

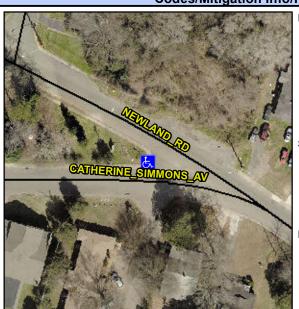
CATHERINE SIMMONS AV Street 1 Name Stop Condition-Street 2 StopSign Street 2 Name N/A Stop Condition-Street 1 N/A Possible Solutions: Compliance Description Remove & Replace Entire Ramp. N/A No N/A Surveyor Notes: N/A PROW/ADA: Not Found, R304.5.1, R304.5.3
