# Access Compliance Report

## Public Rights-of-Way

### (Curb Ramps)

| Intersection ID: 30566 | Main Street: HAMILTON_GREEN_DR | Cross Street: CIRCLEGREEN_DR | Location: NW |

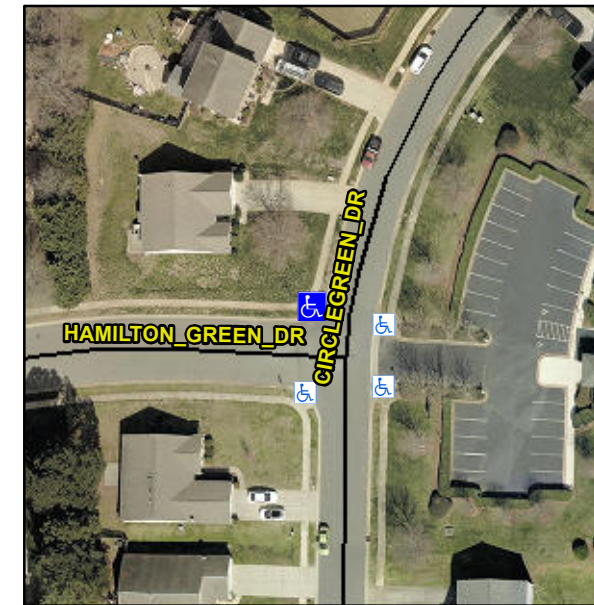
| ADA ID: AF0BB5F31C78 | Ramp Type: BlendTrans2 | Initial Pass/Fail: Pass | Overall Compliance: No |
| | | Severity Score: 15.25 | |

| Compliance | Description | Data | Compliance | Description | Data |
|---|---|---|---|---|---|
| Yes | Ramp Width (in) | 48.0 | No | BlendTrans XSlope (%) | 2.3 |
| N/A | Landing Length (in) | N/A | No | DWS Provided? | No |
| Yes | Gutter Ponding? | No | No | Gutter Slope (%) | 5.6 |

**Remove & Replace Curb Ramp With Two New Directional Ramps or Equivalent. Remove & Replace Gutter.**

**R304.5.3, R305, R304.5.4**

Total Cost: \$ 3950.00
