Access Compliance Report

Public Rights-of-Way

(Curb Ramps)

Intersection ID: N/A	Main Street: MCCLINTOCK_RD	Cross Street: BASCOM_ST	Location: SE
ADA ID: AF10D3764069	Ramp Type: Combination1	Initial Pass/Fail: Fail	Overall Compliance: No
			Severity Score: 13.75

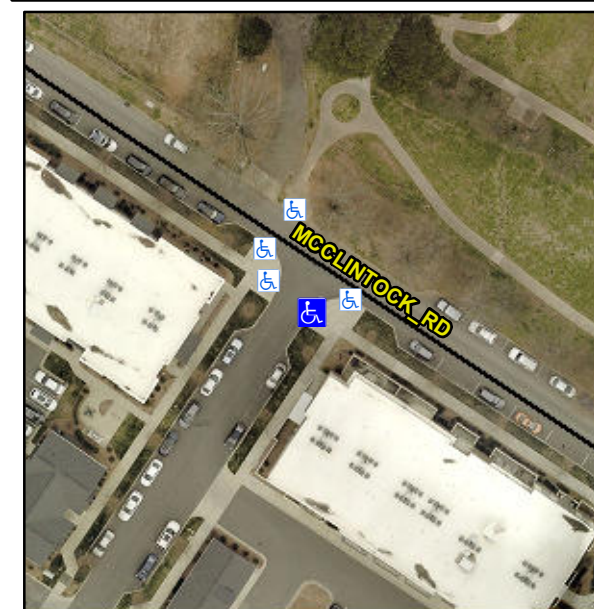
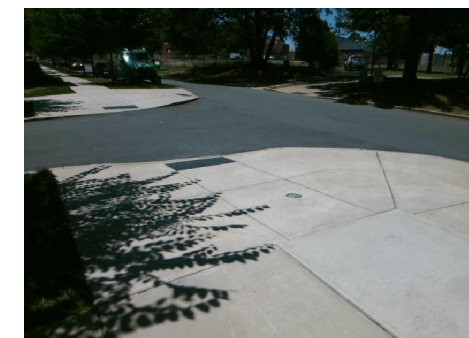
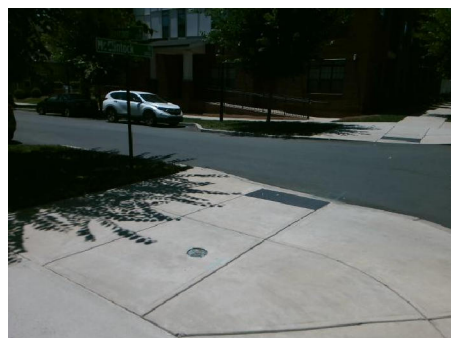
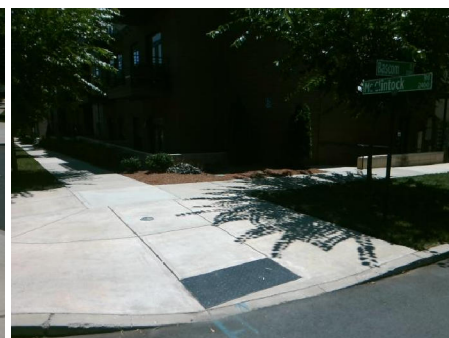
RT RP < 5%

Not Found, R304.3.2, R304.5.3

Compliance	Description	Data	Compliance	Description	Data
N/A	Ramp Length LT (in)	29.0	N/A	Ramp Length RT (in)	71.0
Yes	Ramp Width LT (in)	72.0	Yes	Ramp Width RT (in)	90.0
No	Ramp Slope LT (%)	9.2	Yes	Ramp Slope RT (%)	4.9
No	Ramp XSlope LT (%)	3.3	No	Ramp XSlope RT (%)	3.0
N/A	Ramp Length (in)	151.0	Yes	Ramp Slope (%)	5.1
Yes	Ramp Width (in)	48.0	Yes	Ramp XSlope (%)	1.6
N/A	Flare Type LT	N/A	N/A	Flare Type RT	N/A
N/A	Flare Slope LT (%)	N/A	N/A	Flare Slope RT (%)	N/A
N/A	Flare Traversable LT?	N/A	N/A	Flare Traversable RT?	N/A
N/A	Landing Length (in)	N/A	N/A	DWS Provided?	N/A
N/A	Landing Width (in)	N/A	N/A	DWS Contrast?	N/A
N/A	Landing Slope (%)	N/A	N/A	DWS Length (in)	N/A
N/A	Landing X Slope (%)	N/A	N/A	DWS Full Width?	N/A
N/A	Landing Curb? (Y/N)	N/A	N/A	DWS Offset (in)	N/A
N/A	Shared Landing?	N/A			
N/A	Gutter Ponding?	N/A	N/A	Gutter Slope (%)	N/A
N/A	Gutter Lip Ht (in)	N/A	N/A	Gutter X Slope (%)	N/A
N/A	Painted X Walk1?	No	N/A	Painted X Walk2?	N/A

**Remove & Replace Entire Ramp.
Remove & Replace Sidewalk.**
