Access Compliance Report

Public Rights-of-Way

(Curb Ramps)

Intersection ID: 13802	Main Street: LEXINGTON_AV	Cross Street: MYRTLE_AV	Location:	N
ADA ID: AF28BC472290	Ramp Type: Perp	Initial Pass/Fail: Fail	Overall Compliance: No	Severity Score: 26.25

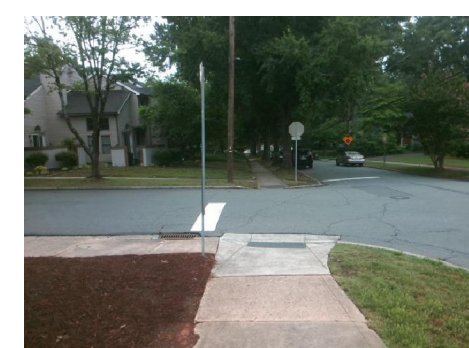
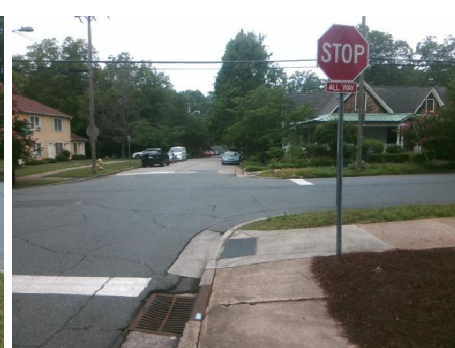
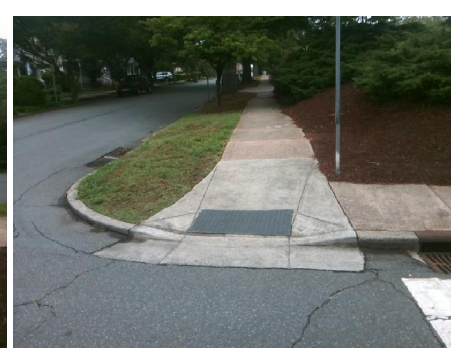
Possible Solutions:		Compliance	Description	Data	Compliance	Description	Data
	Remove & Replace Entire Ramp.		N/A	Ramp Length (in)	165.0	No	Ramp Slope (%)	16.0
			Yes	Ramp Width (in)	48.0	No	Ramp XSlope (%)	4.8
			N/A	Flare Type LT	N/A	N/A	Flare Type RT	N/A
			N/A	Flare Slope LT (%)	N/A	N/A	Flare Slope RT (%)	N/A
			N/A	Flare Traversable LT?	N/A	N/A	Flare Traversable RT?	N/A
			N/A	Landing Length (in)	N/A	N/A	DWS Provided?	N/A
			N/A	Landing Width (in)	N/A	N/A	DWS Contrast?	N/A
			N/A	Landing Slope (%)	N/A	N/A	DWS Length (in)	N/A
			N/A	Landing X Slope (%)	N/A	N/A	DWS Full Width?	N/A
Surveyor Notes:			N/A	Landing Curb? (Y/N)	N/A	N/A	DWS Offset (in)	N/A
N/A			N/A	Shared Landing?	N/A			
PROW/ADA:			N/A	Gutter Ponding?	N/A	N/A	Gutter Slope (%)	N/A
Not Found, R304.2.2, R304.5.3			N/A	Gutter Lip Ht (in)	N/A	N/A	Gutter X Slope (%)	N/A

N/A	Painted X Walk1?	No	N/A	Painted X Walk2?	N/A
				X Walk 1 Direction	To SE		X Walk 2 Direction	N/A
			N/A	X Walk 1 Width (in)	N/A	N/A	X Walk 2 Width (in)	N/A
				X Walk 1 Slope (%)	3.4		X Walk 2 Slope (%)	N/A
				X Walk 1 X Slope (%)	1.7		X Walk 2 X Slope (%)	N/A
			N/A	Ramp inside XWalk1?	N/A	N/A	Ramp inside XWalk2?	N/A
				Road Slope (%)	N/A	N/A	Clear Space?	N/A
				Road X Slope (%)	N/A	N/A	Clear Space to XWalk (in)	N/A
			N/A	Any Obstructions?	N/A	N/A	Storm Grate/Utility Hazard?	N/A
				Obstruction Type			Storm Grate/Utility Type	
						N/A		N/A
						Yes	Surface Condition? (G/P)	Good
