Access Compliance Report

Public Rights-of-Way

(Curb Ramps)

Intersection ID: 9493	Main Street: BRIDGEPORT_DR	Cross Street: CRAFTSBURY_DR	Location: SE
ADA ID: AF2F1A3AB54C	Ramp Type: BlendTrans1	Initial Pass/Fail: Pass	Overall Compliance: No
		Severity Score: 0

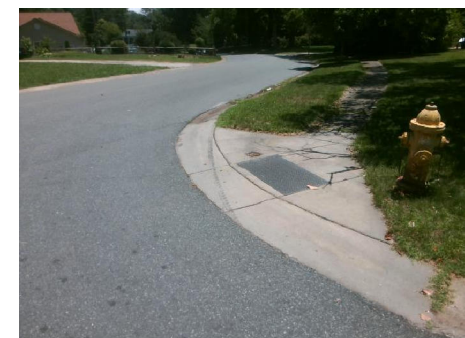
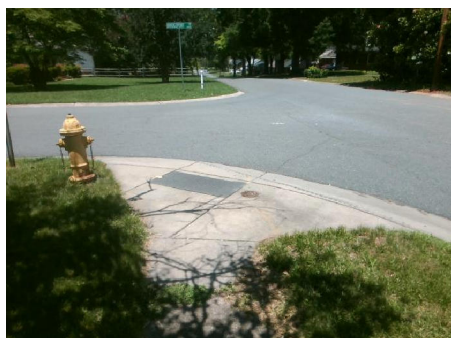
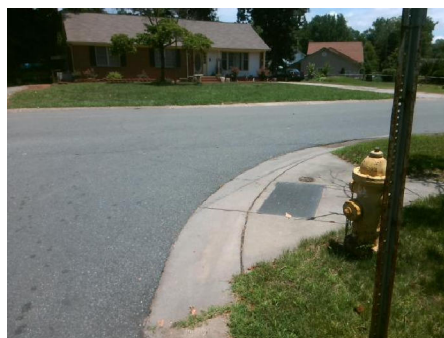
Compliance	Description	Data	Compliance	Description	Data
N/A	Ramp Length (in)	27.0	Yes	BlendTrans Slope (%)	4.3
Yes	Ramp Width (in)	48.0	Yes	BlendTrans XSlope (%)	0.2
N/A	Flare Type LT	Sloped	N/A	Flare Type RT	Sloped
Yes	Flare Slope LT (%)	2.0	N/A	Flare Slope RT (%)	2.7
N/A	Flare Traversable LT?	Yes	N/A	Flare Traversable RT?	No
No	Landing Length (in)	30.0	Yes	DWS Provided?	Yes
Yes	Landing Width (in)	48.0	Yes	DWS Contrast?	Yes
Yes	Landing Slope (%)	0.6	Yes	DWS Length (in)	24.0
Yes	Landing X Slope (%)	0.4	Yes	DWS Full Width?	Yes
N/A	Landing Curb? (Y/N)	No	No	DWS Offset (in)	5.0
N/A	Shared Landing?	No			
No	Gutter Ponding?	Yes	Yes	Gutter Slope (%)	0.9
Yes	Gutter Lip Ht (in)	0.0	Yes	Gutter X Slope (%)	1.5
N/A	Painted X Walk1?	No	N/A	Painted X Walk2?	No
	X Walk 1 Direction	To NE		X Walk 2 Direction	To NW
	X Walk 1 Width (in)	N/A		X Walk 2 Width (in)	N/A
	X Walk 1 Slope (%)	2.7		X Walk 2 Slope (%)	0.8
	X Walk 1 X Slope (%)	0.7		X Walk 2 X Slope (%)	1.8

N/A	Ramp inside XWalk1?	N/A	N/A	Ramp inside XWalk2?	N/A
	Road Slope (%)	3.2		Clear Space?	Yes
	Road X Slope (%)	1.2	N/A	Clear Space to XWalk (in)	N/A
Yes	Any Obstructions?	No	Yes	Storm Grate/Utility Hazard?	No
	Obstruction Type			Storm Grate/Utility Type	
		N/A			N/A
			Yes	Surface Condition? (G/P)	Good
			No	Curb Slope (%)	11.9

Remove & Replace Curb Ramp With Two New Directional Ramps or Equivalent.
