# Access Compliance Report

## Public Rights-of-Way

### (Curb Ramps)

| Intersection ID: 27582 | Main Street: BALLANTYNE_COUNTRY_CLUB_DR | Cross Street: LEDERER_AV | Location: NW |

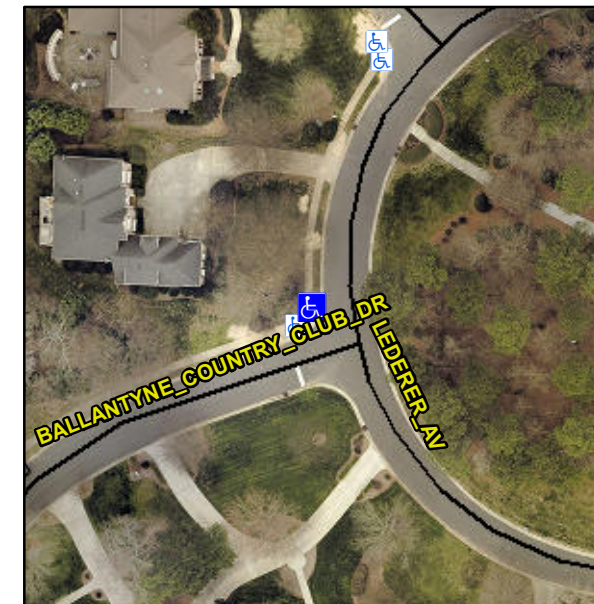
**Not Found, R304.5.3**

| Compliance | Description | Data | Compliance | Description | Data |
|---|---|---|---|---|---|
| Yes | Ramp Width (in) | 48.0 | No | BlendTrans XSlope (%) | 5.3 |
| | | | No | Curb Slope (%) | 15.6 |

**Remove & Replace Curb Ramp With Two New Directional Ramps or Equivalent.**

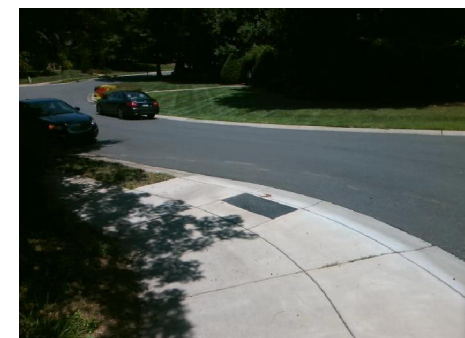
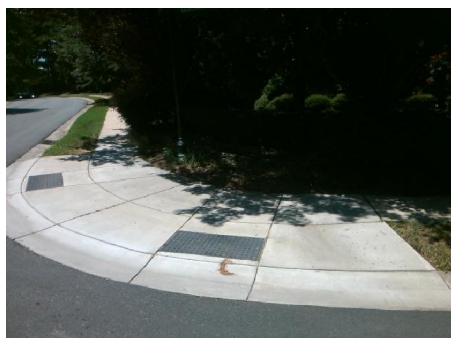
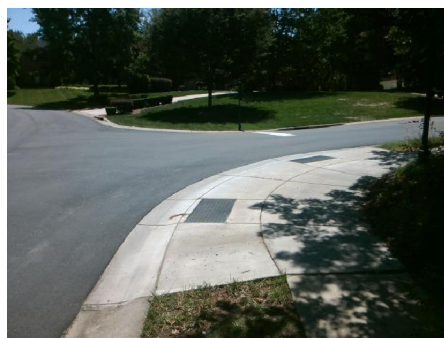
| ADA ID: AF3717A0F46F | Ramp Type: BlendTrans2 | Initial Pass/Fail: Fail | Overall Compliance: No |
| Severity Score: 12.5 | | | |
