Access Compliance Report

Public Rights-of-Way

(Curb Ramps)

Intersection ID: 28071	Main Street: PINE_VALLEY_CLUB_DR	Cross Street: PROVIDENCE_COUNTRY_CLUB_DR	Location: S
ADA ID: AF372A83304A	Ramp Type: Perp	Initial Pass/Fail: Fail	Overall Compliance: No
Severity Score: 12.5			
Codes/Mitigation Info/Possible Solution		Field Measurements/Component Compliance

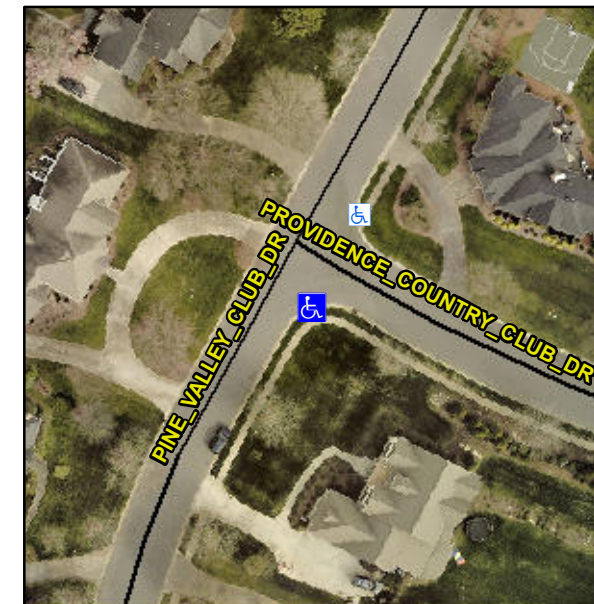
Not Found, R304.5.3

Compliance	Description	Data	Compliance	Description	Data
N/A	Ramp Length (in)	56.0	Yes	Ramp Slope (%)	5.7
Yes	Ramp Width (in)	48.0	No	Ramp XSlope (%)	6.6
N/A	Flare Type LT	N/A	N/A	Flare Type RT	N/A
N/A	Flare Slope LT (%)	N/A	N/A	Flare Slope RT (%)	N/A
N/A	Flare Traversable LT?	N/A	N/A	Flare Traversable RT?	N/A
N/A	Landing Length (in)	N/A	N/A	DWS Provided?	N/A
N/A	Landing Width (in)	N/A	N/A	DWS Contrast?	N/A
N/A	Landing Slope (%)	N/A	N/A	DWS Length (in)	N/A
N/A	Landing X Slope (%)	N/A	N/A	DWS Full Width?	N/A
N/A	Landing Curb? (Y/N)	N/A	N/A	DWS Offset (in)	N/A
N/A	Shared Landing?	N/A			
N/A	Gutter Ponding?	N/A	N/A	Gutter Slope (%)	N/A
N/A	Gutter Lip Ht (in)	N/A	N/A	Gutter X Slope (%)	N/A
N/A	Painted X Walk1?	No	N/A	Painted X Walk2?	N/A
	X Walk 1 Direction	To NE		X Walk 2 Direction	N/A
N/A	X Walk 1 Width (in)	N/A	N/A	X Walk 2 Width (in)	N/A
	X Walk 1 Slope (%)	1.2		X Walk 2 Slope (%)	N/A
	X Walk 1 X Slope (%)	3.4		X Walk 2 X Slope (%)	N/A

N/A	Ramp inside XWalk1?	N/A	N/A	Ramp inside XWalk2?	N/A
	Road Slope (%)	N/A	N/A	Clear Space?	N/A
	Road X Slope (%)	N/A	N/A	Clear Space to XWalk (in)	N/A
N/A	Any Obstructions?	N/A	N/A	Storm Grate/Utility Hazard?	N/A
	Obstruction Type			Storm Grate/Utility Type	
		N/A			N/A
		Yes		Surface Condition? (G/P)	Good

Possible Solutions:

Remove & Replace Entire Ramp.
