# Access Compliance Report

## Public Rights-of-Way

### (Curb Ramps)

Intersection ID: 17203	Main Street: IRBY_DR	Cross Street: WESTFIELD_RD	Location: W
ADA ID: AF5FD9B246B6	Ramp Type: PerpDiag	Initial Pass/Fail: Fail	Overall Compliance: No
Severity Score: 13.75			
Codes/Mitigation Info/Possible Solution		Field Measurements/Component Compliance

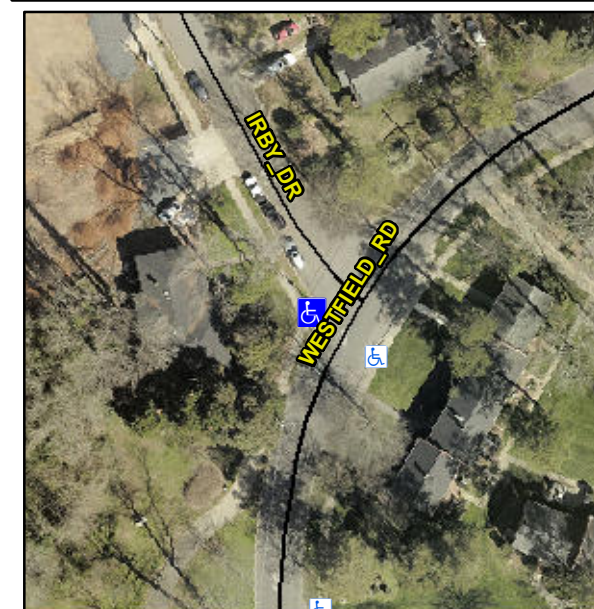
**Not Found, R304.2.2, R304.5.3**

Compliance	Description	Data	Compliance	Description	Data
N/A	Ramp Length (in)	46.0	No	Ramp Slope (%)	9.1
Yes	Ramp Width (in)	48.0	No	Ramp XSlope (%)	2.5
N/A	Flare Type LT	N/A	N/A	Flare Type RT	N/A
N/A	Flare Slope LT (%)	N/A	N/A	Flare Slope RT (%)	N/A
N/A	Flare Traversable LT?	N/A	N/A	Flare Traversable RT?	N/A
N/A	Landing Length (in)	N/A	N/A	DWS Provided?	N/A
N/A	Landing Width (in)	N/A	N/A	DWS Contrast?	N/A
N/A	Landing Slope (%)	N/A	N/A	DWS Length (in)	N/A
N/A	Landing X Slope (%)	N/A	N/A	DWS Full Width?	N/A
N/A	Landing Curb? (Y/N)	N/A	N/A	DWS Offset (in)	N/A
N/A	Shared Landing?	N/A			
N/A	Gutter Ponding?	N/A	N/A	Gutter Slope (%)	N/A
N/A	Gutter Lip Ht (in)	N/A	N/A	Gutter X Slope (%)	N/A
N/A	Painted X Walk1?	No	N/A	Painted X Walk2?	No
	X Walk 1 Direction	To SE		X Walk 2 Direction	To NE
N/A	X Walk 1 Width (in)	N/A	N/A	X Walk 2 Width (in)	N/A
	X Walk 1 Slope (%)	4.9		X Walk 2 Slope (%)	5.2
	X Walk 1 X Slope (%)	2.9		X Walk 2 X Slope (%)	1.1

N/A	Ramp inside XWalk1?	N/A	N/A	Ramp inside XWalk2?	N/A
	Road Slope (%)	0.8	N/A	Clear Space?	N/A
	Road X Slope (%)	2.8	N/A	Clear Space to XWalk (in)	N/A
N/A	Any Obstructions?	N/A	N/A	Storm Grate/Utility Hazard?	N/A
	Obstruction Type			Storm Grate/Utility Type	
		N/A			N/A
			Yes	Surface Condition? (G/P)	Good

**Remove & Replace Curb Ramp With Two New Directional Ramps or Equivalent.**
