# Access Compliance Report

## Public Rights-of-Way (Curb Ramps)

Intersection ID: 49399	Main Street: CHILFORD_CT	Cross Street: HEREFORD_ST	Location:	N
ADA ID: AF63175BDCBC	Ramp Type: BlendTrans1	Initial Pass/Fail: Fail	Overall Compliance: No	Severity Score: 8.75
Codes/Mitigation Info/Possible Solution		Field Measurements/Component Compliance

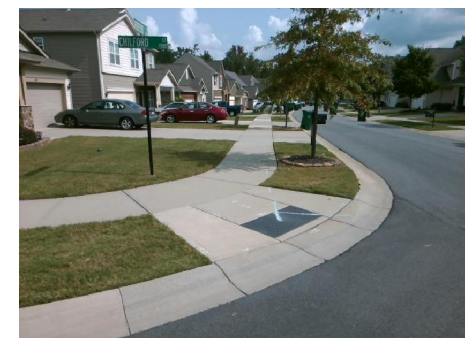
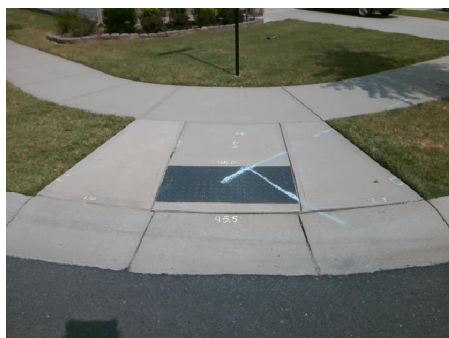
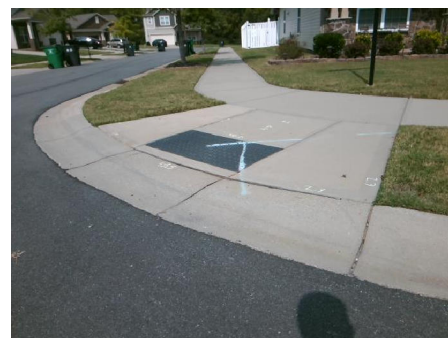
**Not Found, R304.5.1**

Compliance	Description	Data	Compliance	Description	Data
N/A	Ramp Length (in)	71.5	Yes	BlendTrans Slope (%)	2.9
No	Ramp Width (in)	46.0	Yes	BlendTrans XSlope (%)	0.6
N/A	Flare Type LT	N/A	N/A	Flare Type RT	N/A
N/A	Flare Slope LT (%)	N/A	N/A	Flare Slope RT (%)	N/A
N/A	Flare Traversable LT?	N/A	N/A	Flare Traversable RT?	N/A
N/A	Landing Length (in)	N/A	N/A	DWS Provided?	N/A
N/A	Landing Width (in)	N/A	N/A	DWS Contrast?	N/A
N/A	Landing Slope (%)	N/A	N/A	DWS Length (in)	N/A
N/A	Landing X Slope (%)	N/A	N/A	DWS Full Width?	N/A
N/A	Landing Curb? (Y/N)	N/A	N/A	DWS Offset (in)	N/A
N/A	Shared Landing?	N/A			
N/A	Gutter Ponding?	N/A	N/A	Gutter Slope (%)	N/A
N/A	Gutter Lip Ht (in)	N/A	N/A	Gutter X Slope (%)	N/A
N/A	Painted X Walk1?	No	N/A	Painted X Walk2?	No
	X Walk 1 Direction	To SW		X Walk 2 Direction	To SE
	X Walk 1 Width (in)	N/A		X Walk 2 Width (in)	N/A
	X Walk 1 Slope (%)	2.2		X Walk 2 Slope (%)	2.3
	X Walk 1 X Slope (%)	1.6		X Walk 2 X Slope (%)	2.3

N/A	Ramp inside XWalk1?	N/A	N/A	Ramp inside XWalk2?	N/A
	Road Slope (%)	0.6		Clear Space?	N/A
	Road X Slope (%)	3.7	N/A	Clear Space to XWalk (in)	N/A
N/A	Any Obstructions?	N/A	N/A	Storm Grate/Utility Hazard?	N/A
	Obstruction Type			Storm Grate/Utility Type	
		N/A			N/A
			Yes	Surface Condition? (G/P)	Good
			No	Curb Slope (%)	15.6

**Remove & Replace Curb Ramp With Two New Directional Ramps or Equivalent.**
