# Access Compliance Report

## Public Rights-of-Way

### (Curb Ramps)

Intersection ID: 12244	Main Street: BELMONT_AV	Cross Street: HARRILL_ST	Location: S
ADA ID: AF6A41C28BED	Ramp Type: BlendTrans1	Initial Pass/Fail: Fail	Overall Compliance: No
			Severity Score: 33.75

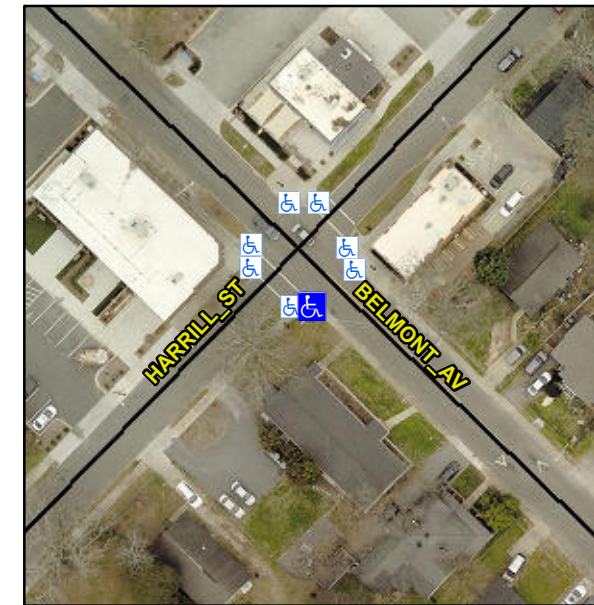
**Not Found, R304.5.1, R304.5.3**

Compliance	Description	Data	Compliance	Description	Data
N/A	Ramp Length (in)	46.5	Yes	BlendTrans Slope (%)	2.8
No	Ramp Width (in)	47.0	No	BlendTrans XSlope (%)	8.0
N/A	Flare Type LT	N/A	N/A	Flare Type RT	N/A
N/A	Flare Slope LT (%)	N/A	N/A	Flare Slope RT (%)	N/A
N/A	Flare Traversable LT?	N/A	N/A	Flare Traversable RT?	N/A
N/A	Landing Length (in)	N/A	N/A	DWS Provided?	N/A
N/A	Landing Width (in)	N/A	N/A	DWS Contrast?	N/A
N/A	Landing Slope (%)	N/A	N/A	DWS Length (in)	N/A
N/A	Landing X Slope (%)	N/A	N/A	DWS Full Width?	N/A
N/A	Landing Curb? (Y/N)	N/A	N/A	DWS Offset (in)	N/A
N/A	Shared Landing?	N/A			
N/A	Gutter Ponding?	N/A	N/A	Gutter Slope (%)	N/A
N/A	Gutter Lip Ht (in)	N/A	N/A	Gutter X Slope (%)	N/A
N/A	Painted X Walk1?	No	N/A	Painted X Walk2?	N/A
	X Walk 1 Direction	To NE		X Walk 2 Direction	N/A
	X Walk 1 Width (in)	N/A		X Walk 2 Width (in)	N/A
	X Walk 1 Slope (%)	3.4		X Walk 2 Slope (%)	N/A
	X Walk 1 X Slope (%)	4.3		X Walk 2 X Slope (%)	N/A

N/A	Ramp inside XWalk1?	N/A	N/A	Ramp inside XWalk2?	N/A
	Road Slope (%)	4.3		Clear Space?	N/A
	Road X Slope (%)	3.4	N/A	Clear Space to XWalk (in)	N/A
N/A	Any Obstructions?	N/A	N/A	Storm Grate/Utility Hazard?	N/A
	Obstruction Type			Storm Grate/Utility Type	
		N/A			N/A
			Yes	Surface Condition? (G/P)	Good
			No	Curb Slope (%)	8.0

**Remove & Replace Curb Ramp With Two New Directional Ramps or Equivalent.**
