## Access Compliance Report Public Rights-of-Way (Curb Ramps)

Intersection ID: 32186 Main Street: ANNABEL\_LEE\_LN Cross Street: MARIE\_ROGET\_WY Location: S

ADA ID: AF70AD644CE8 Ramp Type: PerpDiag Initial Pass/Fail: Fail Overall Compliance: No Severity Score: 21.25

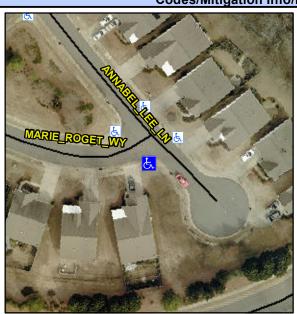
Compliance Description Data Compliance Description Data No N/A Ramp Length (in) 52.0 Ramp Slope (%) 8.7 Yes Ramp XSlope (%) No Ramp Width (in) 36.0 2.0 N/A N/A Flare Type LT N/A Flare Type RT N/A N/A N/A N/A Flare Slope RT (%) N/A Flare Slope LT (%) N/A Flare Traversable LT? N/A N/A Flare Traversable RT? N/A N/A N/A N/A DWS Provided? N/A Landing Length (in) N/A Landing Width (in) N/A N/A **DWS Contrast?** N/A N/A N/A N/A Landing Slope (%) DWS Length (in) N/A N/A Landing X Slope (%) N/A N/A DWS Full Width? N/A N/A Landing Curb? (Y/N) N/A N/A DWS Offset (in) N/A N/A N/A Shared Landing? N/A **Gutter Ponding?** N/A N/A Gutter Slope (%) N/A N/A Gutter Lip Ht (in) N/A N/A Gutter X Slope (%) N/A N/A Painted X Walk1? No N/A Painted X Walk2? No X Walk 1 Direction To NE X Walk 2 Direction To NW N/A N/A N/A X Walk 1 Width (in) X Walk 2 Width (in) N/A X Walk 1 Slope (%) 3.7 X Walk 2 Slope (%) 2.0 X Walk 1 X Slope (%) 0.2 X Walk 2 X Slope (%) 1.4 N/A N/A N/A Ramp inside XWalk2? N/A Ramp inside XWalk1? Road Slope (%) 0.7 N/A Clear Space? N/A N/A Road X Slope (%) 2.2 Clear Space to XWalk (in) N/A N/A N/A N/A Any Obstructions? Storm Grate/Utility Hazard? N/A **Obstruction Type** Storm Grate/Utility Type N/A N/A Yes Surface Condition? (G/P) Good

Remove & Replace Curb Ramp With
Two New Directional Ramps or
Equivalent.
