# Access Compliance Report

## Public Rights-of-Way

### (Curb Ramps)

Intersection ID: 10021684	Main Street: BRAY_DR	Cross Street: N/A	Location: SW
ADA ID: AF766AB9F0B7	Ramp Type: Perp	Initial Pass/Fail: Fail	Overall Compliance: No
Severity Score: 21.25			
Codes/Mitigation Info/Possible Solution		Field Measurements/Component Compliance

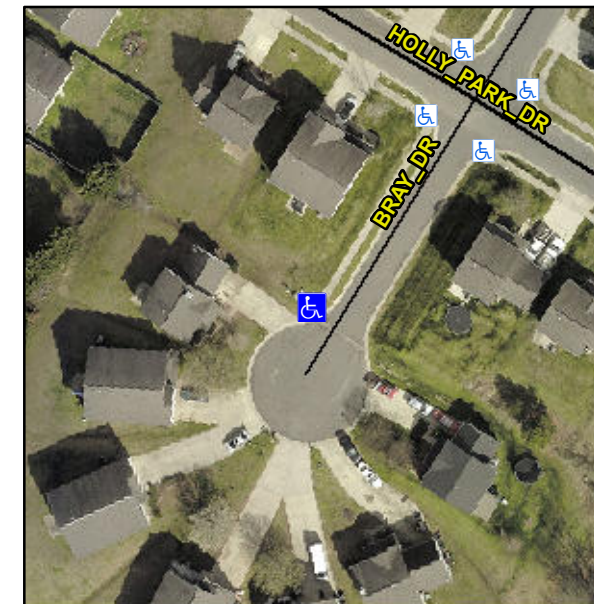
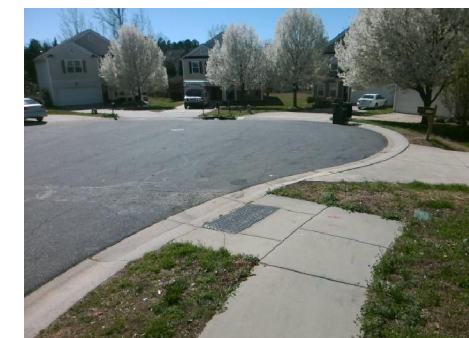
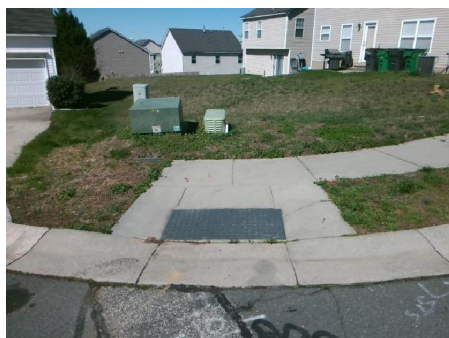
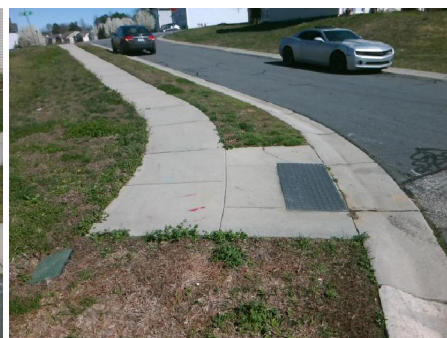
Compliance	Description	Data	Compliance	Description	Data
N/A	Ramp Length (in)	50.0	Yes	Ramp Slope (%)	7.2
No	Ramp Width (in)	43.0	No	Ramp XSlope (%)	5.2
N/A	Flare Type LT	N/A	N/A	Flare Type RT	N/A
N/A	Flare Slope LT (%)	N/A	N/A	Flare Slope RT (%)	N/A
N/A	Flare Traversable LT?	N/A	N/A	Flare Traversable RT?	N/A
N/A	Landing Length (in)	N/A	N/A	DWS Provided?	N/A
N/A	Landing Width (in)	N/A	N/A	DWS Contrast?	N/A
N/A	Landing Slope (%)	N/A	N/A	DWS Length (in)	N/A
N/A	Landing X Slope (%)	N/A	N/A	DWS Full Width?	N/A
N/A	Landing Curb? (Y/N)	N/A	N/A	DWS Offset (in)	N/A
N/A	Shared Landing?	N/A			
N/A	Gutter Ponding?	N/A	N/A	Gutter Slope (%)	N/A
N/A	Gutter Lip Ht (in)	N/A	N/A	Gutter X Slope (%)	N/A
N/A	Painted X Walk1?	No	N/A	Painted X Walk2?	N/A
	X Walk 1 Direction	To E		X Walk 2 Direction	N/A
N/A	X Walk 1 Width (in)	N/A	N/A	X Walk 2 Width (in)	N/A
	X Walk 1 Slope (%)	0.9		X Walk 2 Slope (%)	N/A
	X Walk 1 X Slope (%)	6.1		X Walk 2 X Slope (%)	N/A

N/A	Ramp inside XWalk1?	N/A	N/A	Ramp inside XWalk2?	N/A
	Road Slope (%)	6.1	N/A	Clear Space?	N/A
	Road X Slope (%)	0.9	N/A	Clear Space to XWalk (in)	N/A
N/A	Any Obstructions?	N/A	N/A	Storm Grate/Utility Hazard?	N/A
	Obstruction Type			Storm Grate/Utility Type	
		N/A			N/A
		Yes		Surface Condition? (G/P)	Good

Possible Solutions:

**Remove & Replace Entire Ramp.**

**R304.5.1, R304.5.3**
