# Access Compliance Report

## Public Rights-of-Way

### (Curb Ramps)

| Intersection ID: 10016113 | Main Street: N_SHARON_AMITY_RD | Cross Street: N/A | Location: E |

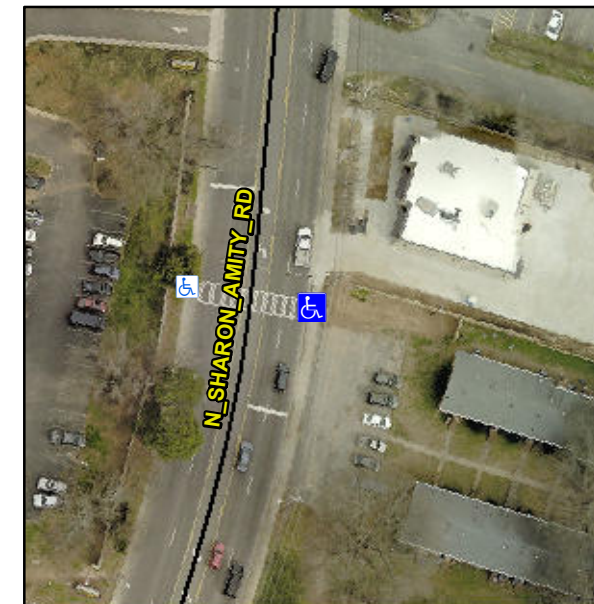
| ADA ID: AF7D5225F1E5 | Ramp Type: Perp | Initial Pass/Fail: Fail | Overall Compliance: No |
| | | Severity Score: 12.5 | |

**Not Found, R304.2.2**

| Compliance | Description | Data | Compliance | Description | Data |
|---|---|---|---|---|---|
| N/A | Ramp Length (in) | 59.0 | No | Ramp Slope (%) | 8.8 |

**Remove & Replace Entire Ramp.**

Total Cost: \$ 1850.00
